ANALYSIS OF CASE STUDIES IN
RECOVERY AND RECONSTRUCTION

CASE STUDIES

Patan, Nepal • Taishun, China • Nyanza, Rwanda
Aleppo, Syria • San Pedro de Alcántara, O'Higgins Region, Chile
WH Cultural Landscape Wachau, Austria • San Luis Potosí, México

VOL. 2

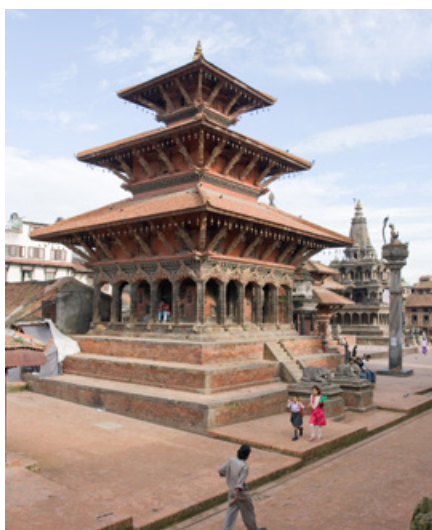
Fig. 5. Example of a tiered temple: Harishankara Temple at the Patan Durbar Square before the earthquake 2015 (Institute of Conservation, University of Applied Arts Vienna, 2017, photo by Christoph Schießmann)

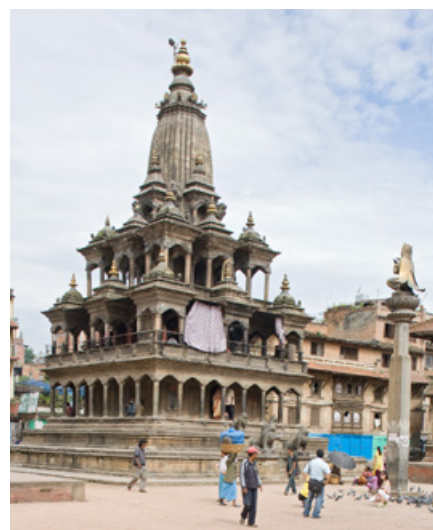
Fig. 6. Example of a Shikhara-style temple: Krishna Mandir at Patan Durbar Square before the earthquake 2015 (Kathmandu Valley Preservation Trust, 2008, photo by Stanislaw Klimek)

The other existing temple typology is the Shikhara-style temple, a Nepalese adaption of the Indian stone temples, of which three are located on the square (Korn 1976: 80; Bonapace, Sestini 2003: 9). Two of them are built of small stone blocks pointed with mortars (fig. 6), whereby varying mixtures were applied in the framework of previous restoration and repair work. The remaining one is built of brick. Lime plaster was later added to prevent biological growth.

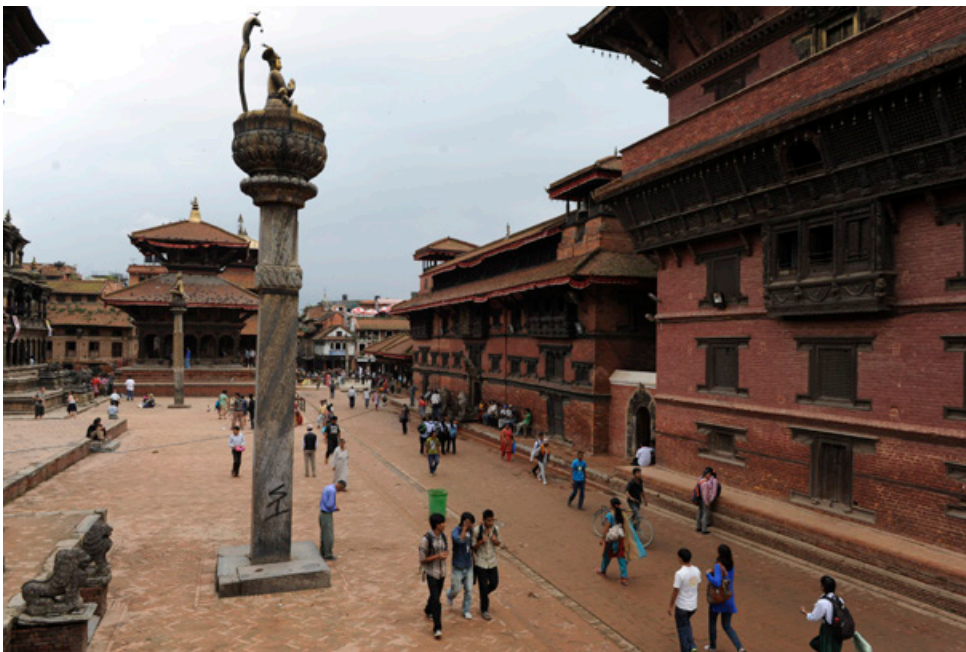
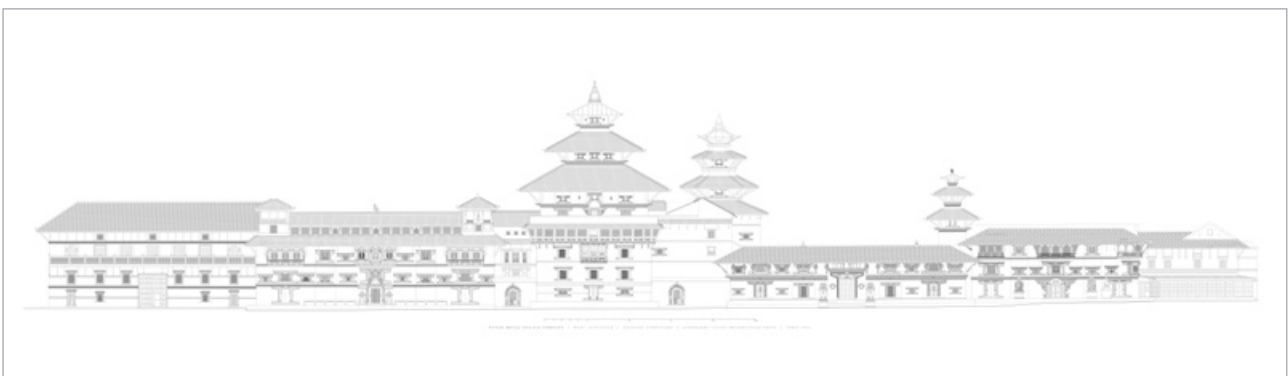
◀
From top to bottom:
Fig. 7. View at the Pillar of Yoganarendra Malla (left) and the Royal Palace (right) before the earthquake 2015 (Institute of Conservation, University of Applied Arts Vienna, 2013)
Fig. 8. Patan Royal Palace Complex, existing west elevation (Kathmandu Valley Preservation Trust)

The Royal Palace, the largest structure within the urban ensemble, comprises multiple interlinked multi-storeyed buildings and temples arranged around three courtyards. (figg. 7-8) Similar to the tiered temples, the

palace is made of brick masonry in a structural wooden frame adorned with highly decorated timber windows, doors, roof struts and cornices.

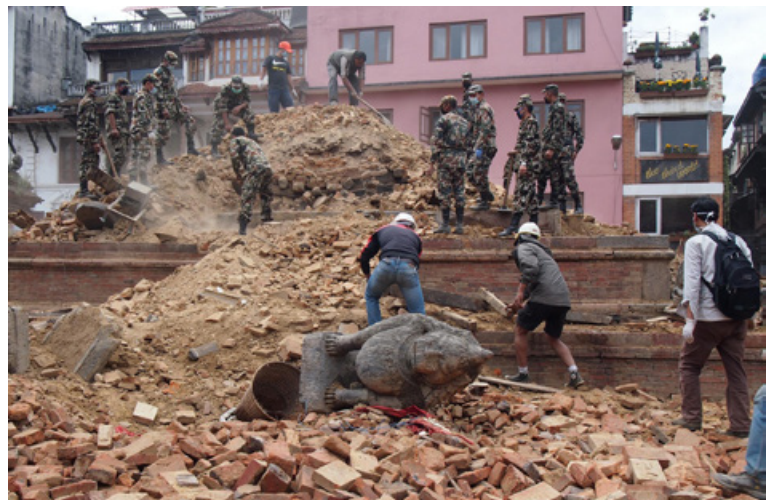
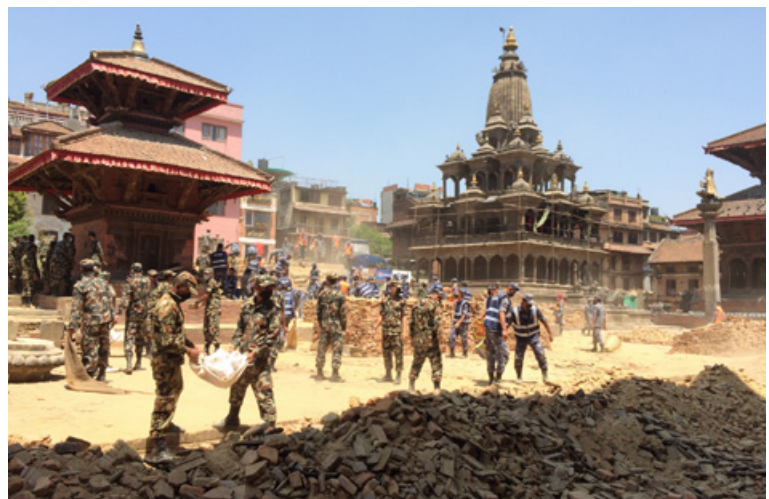
► **From top to bottom:**
Fig. 17. Artefacts and decorative components were manually recovered from the debris of collapsed temples (Thomas Schrom, 2015)
Fig. 18. The recovery of elements was jointly carried out with the help of local stakeholders, the local community, the Nepal Army, the Armed Police Force and the Police (Kathmandu Valley Preservation Trust, 2015)

It is notable that in the immediate aftermath of the earthquake well-organised local communities started not only to rescue human beings but also to recover and secure unique architectural elements like statues and carved wooden elements (Manhart 2018). Some local people even rushed to the site immediately after the earthquake to protect artefacts from theft. The overall rescue and recovery of works of art was coordinated by the DoA together with the KVPT. It was carried out with the help of local stakeholders, the local community and the Nepal Army, the Armed Police Force and the Police (figg. 17-18).

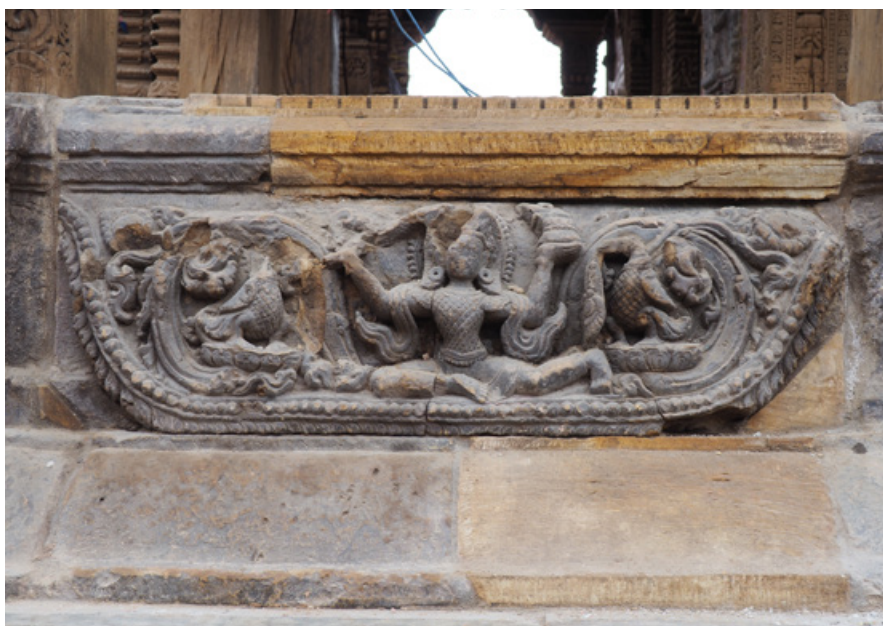
► **Fig. 25.** Historical elements were re-used and only considerably damaged parts were partially replaced – in this case the top profile was replaced with a stone indent made by a local stone mason (Institute of Conservation, University of Applied Arts Vienna, 2018)

- Fig. 24. The damaged wings of the Royal Palace were covered with tarpaulins
- Fig. 25. Historical elements were re-used, and only badly damaged parts were partially replaced – in this case the top profile was replaced with a stone indent made by a local stone mason

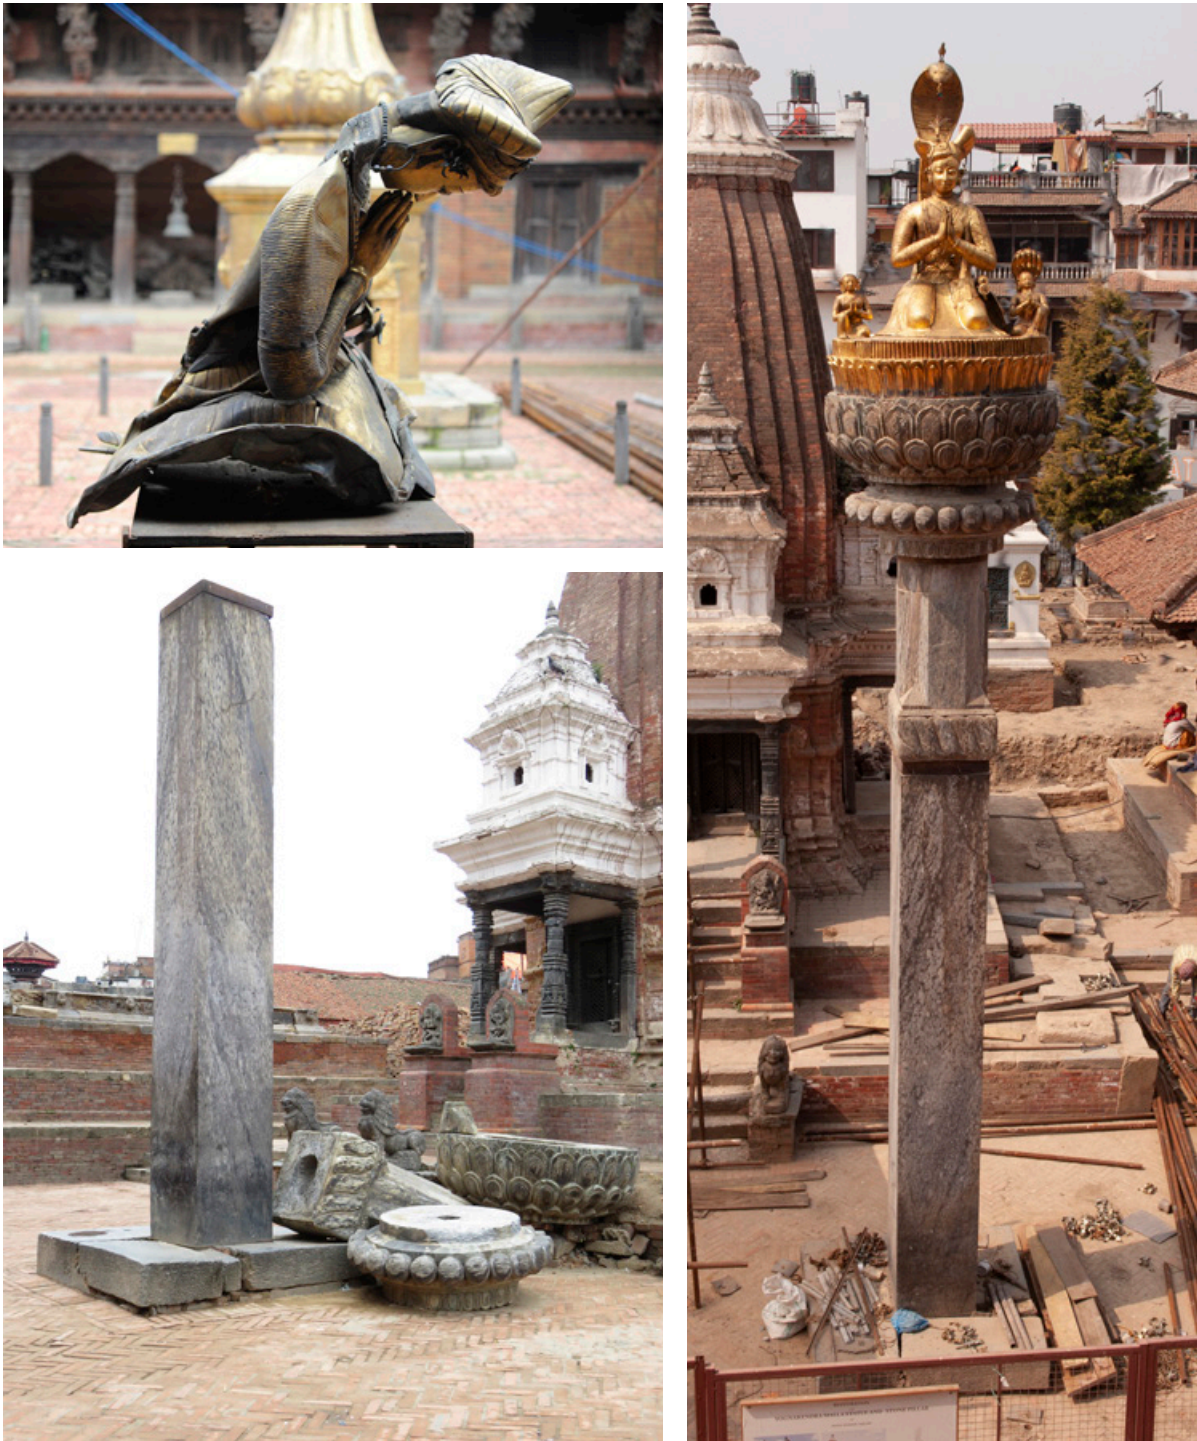
▲
Fig. 28. The Pillar of Yoganarendra Malla after the earthquake (left) and after its successful conservation and re-erection (right) (Institute of Conservation, University of Applied Arts Vienna, 2015-2017)

The achievements so far comprise the thorough conservation, restoration and reconstruction of most of the significant structures that are integral parts of Patan Durbar Square (compare 3.4.). The Krishna Mandir and Vishveshvara Temple underwent structural rehabilitation and conservation, the Harishankara Temple was reconstructed, the reconstruction of Charnarayana Temple is still in full progress and work at the Royal Palace was partly accomplished. Apart from the work on these priorities, the conservation and re-assembling of two partly collapsed free-standing pillars together with their crowning sculptures (Lion Pillar and Pillar of Yoganarendra Malla) are among the main achievements (fig. 28).

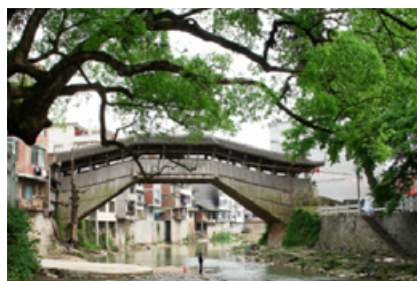
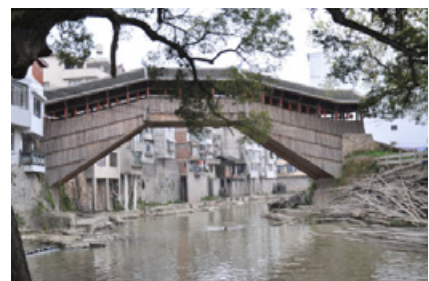
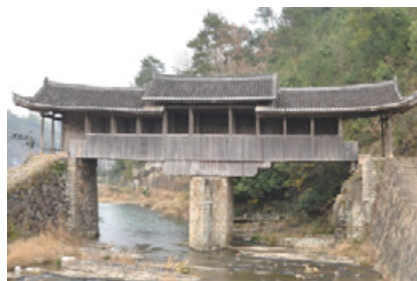
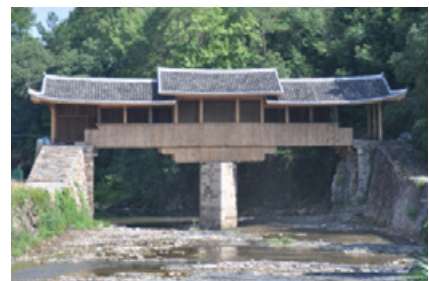
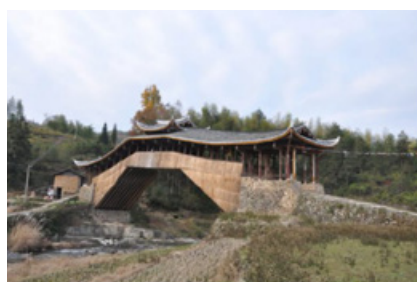
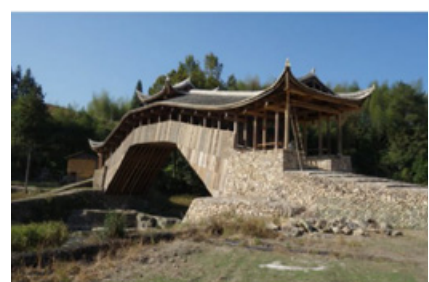
►
From top to bottom:
Fig. 1. Xuezhai Bridge
Fig. 2. Wenzhong Bridge
Fig. 3. Wenxing Bridge

The heritage composition of the three wooden arch bridges includes the physical bridge and intangible heritage. The physical bridge consists of two parts: the bridge and its subsidiary part. The bridge consists of the abutment (pier), bridge body (wooden arches) and covered house; The subsidiary part includes the surrounding water system, barges, ancient roads, bridge houses, rural landscape, as well as inscriptions, plaques, niche for a statue of the Buddha and inscriptions on a stone tablet related to the wooden arch bridge. The intangible heritage includes bridge building customs, building techniques, building families and stories. The mountainous terrain itself underlies all aspects of this heritage. These bridges are mainly used as small ritual spaces.

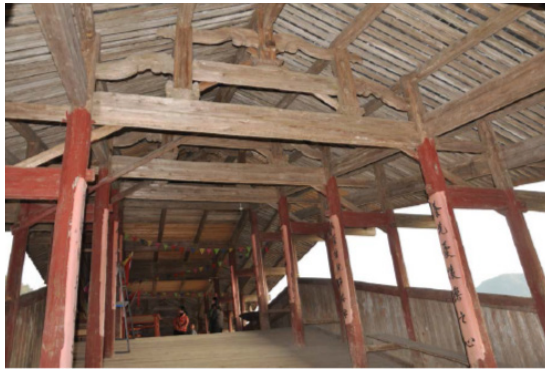
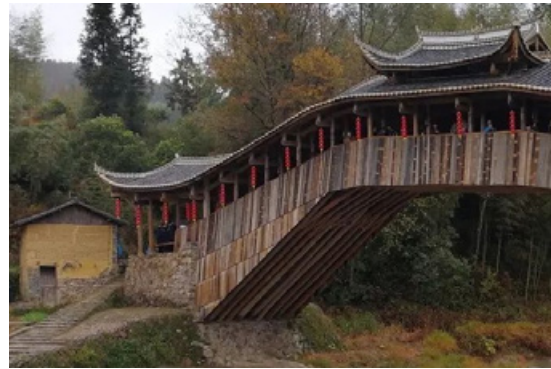
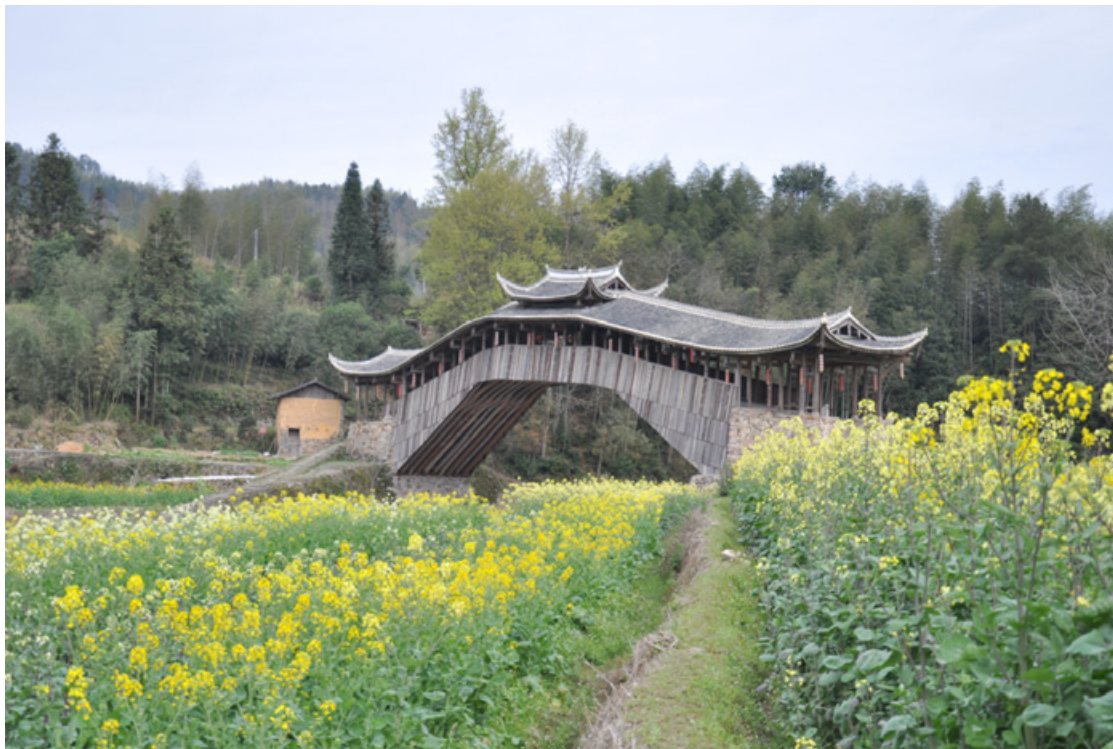
▲
Images, Clockwise from top left:
Fig. 8. Covered house of Wenxing Bridge
Fig. 9. Bridge house
Fig. 10. Surroundings of Wenxing Bridge

Bridge house: Located at the north-western end of the bridge and was built to protect Wenxing Bridge (fig. 9).

Surroundings: Wenxing Bridge is located to the northwest of the town of Xiaocun; it spans the Yu Stream with Wentai Highway 200 metres to its east. Yu Stream is a tributary of the Feiyun River flowing into the Shanxi Reservoir (Feiyun Lake) to the north. On the two ends of the bridge, the ancient road at the mouth of the river and farmlands on its south side are well-preserved (fig. 10).

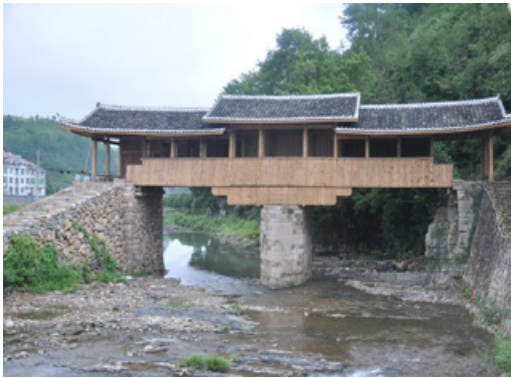
▲
Images, Clockwise from top left:
Fig. 11. Wenzhong Bridge
Fig. 12. Bridge body of Wenzhong Bridge
Fig. 13. Covered houses of Wenzhong Bridge

Covered house: This is 25.4 metres long, 4.17 metres wide, and has eleven bays built of forty-six columns. Each column-and-tie truss is composed of seven purlins and four posts. The three bays in the centre are raised to form an overhanging garble roof, while the bays on the two sides have a gable and hip roof (fig. 13).

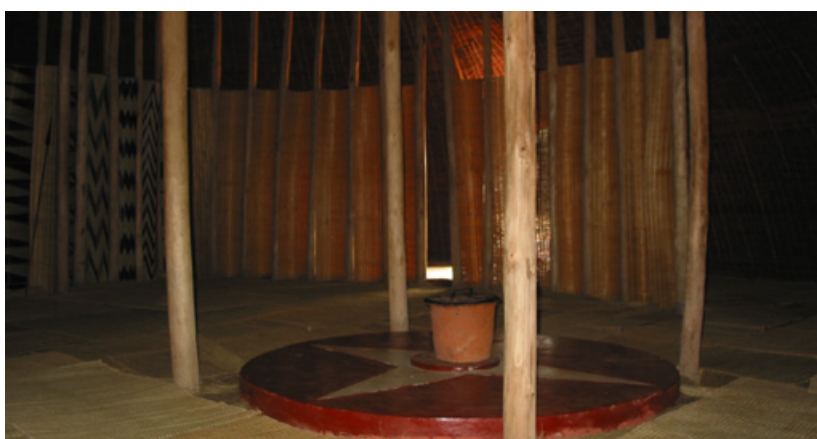
►
Images, Clockwise from top left:
Fig. 5. Ceiling (*Ipfuno*) of a traditional hut
Fig. 6. Diamond-shaped capitels linking the wooden pillars to the ceiling of the Hubert Ngenzi hut in the Museum of Rwanda
Fig. 7. Typical hearth in the centre of the Hubert Ngenzi hut in the Museum of Rwanda

The traditional huts were designed for protecting and taking advantage from the environmental conditions. Without any other opening besides the entrance, the hut maintained itself fresh inside during the day and warmer at night. They used to have a central hearth for giving light inside the hut, reducing the humidity and warming up the space (fig. 7). The smoke would go out through the entrance. This smoke was useful for keeping mosquitoes and other insects away from the interior of the huts.

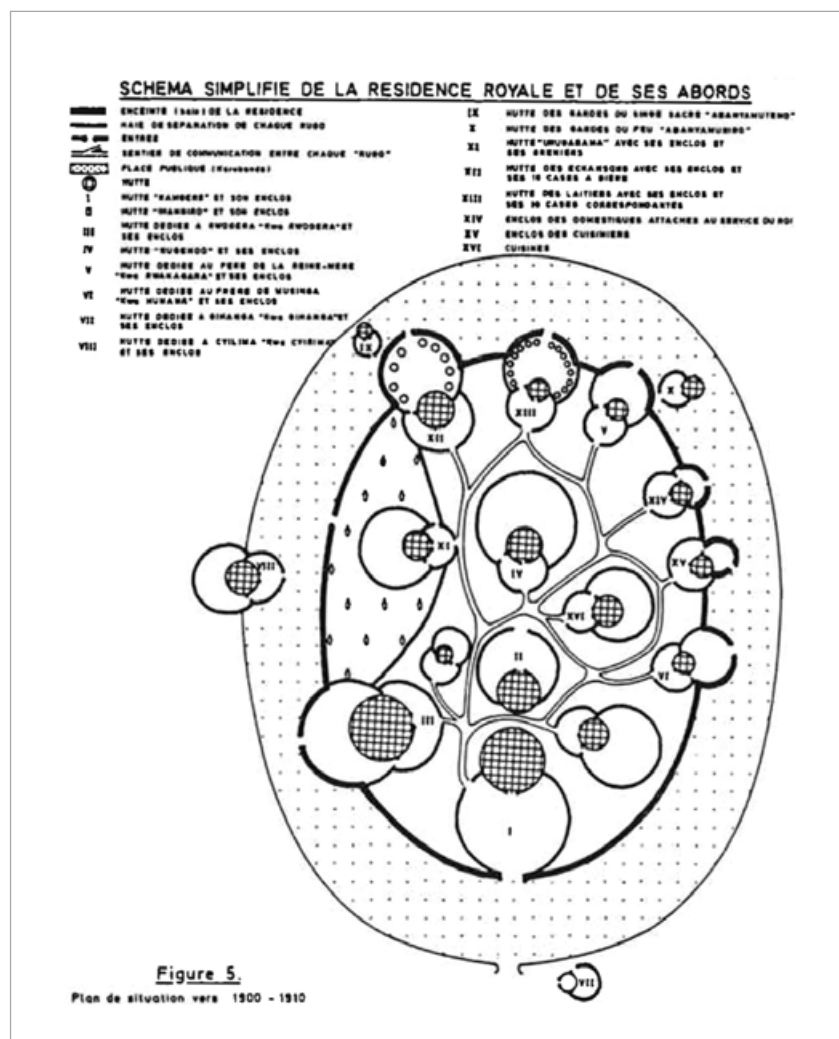
Fig. 8. Plan for the proposed reconstruction of the Royal Capital as described in Lugan's account

- The traditional huts of the Royal Capital described in Lugan's account and which it is planned to reconstruct are the following sixteen: (fig. 8)
1. Hut I: Close to the central entrance of the residence, it was the largest hut, called *Kambere* and dedicated to the Mwami (King) Kigeri IV Rwabugiri (1853-1895), father of Musinga. This hut was between 14 metres and 16 metres in diameter and 7 metres high. It had an *Igitabo*, which was an entrance made of clay and which was 30 cm. high and semi-circular; it protected the entrance to the hut from water and humidity. A small hut dedicated to the *Inzu*, the lineage ancestor, was used for rituals where the descendants gathered and gave offerings to calm their ancestor's spirit.

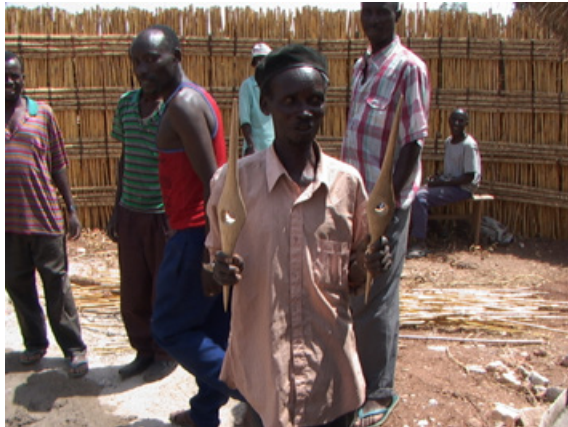
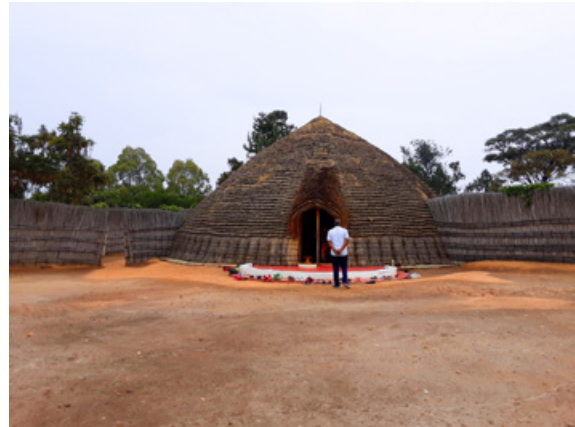
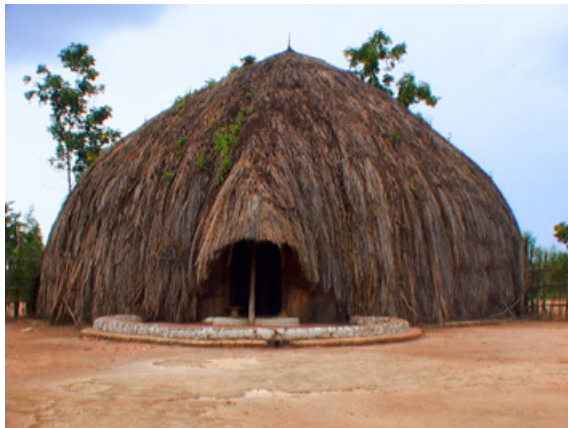
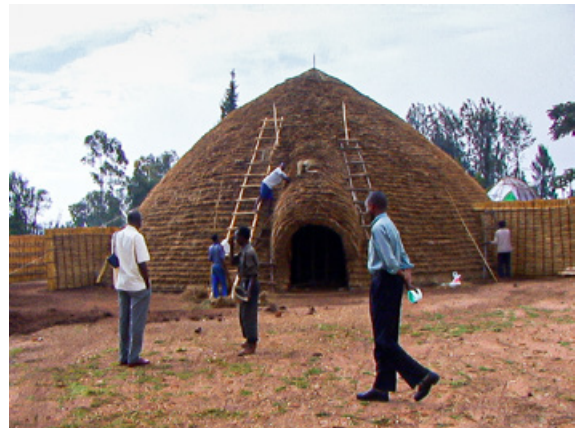
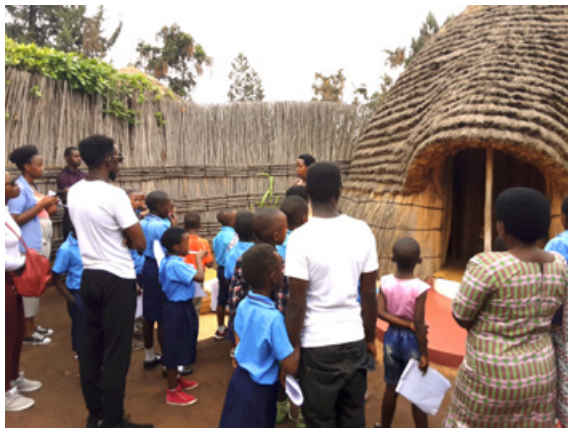
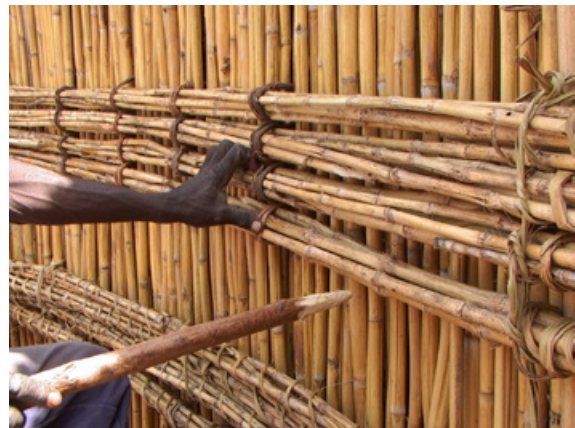
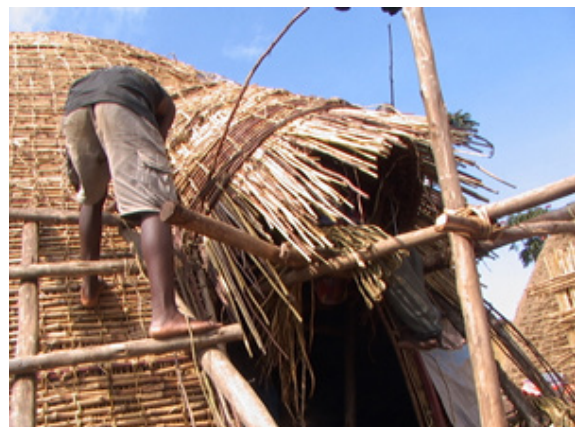
▲
Images, Clockwise from top left:
Fig. 19. Skilled elders
Fig. 20a-e. Building three huts in the traditional style
Fig. 21. Traditional hut on Rukari hill built for the National Ballet

In the context of modernisation and economical reconstitution as a priority for Rwanda after the Genocide, Professor Kanimba Misago's project was a way to use culture for recovery. It was not the first attempt at reconstituting this cultural element; in the late 1980s, on the same Rukari hill, a traditional hut was constructed to be used by the national ballet, *Urukerereza* in its cultural performances. Materials were collected from the hills around Rukari by members of the ballet and *Abagorozi* guided the construction works according to Mr Jean Baptiste Nkurikiyinka, a staff member of the National Ballet (fig. 21). These materials were made of *urubingo* (*pennisetum purpurem*), *urukangaga* (*cyperius latifolius*), and *uruguhu* (*miscanthus* sp). Today, such materials are only found more than 100 km. from Rukari.

In this way, the project of reconstruction did not follow the traditional system of selecting the hill or not constructing in a sacred area where a previous king used to live. Nevertheless, the reconstruction required an in-depth research on the traditional building system in which King Musinga's huts were originally constructed. This implied research on the materials, techniques and processes for construction. However, no documentation of the research or the reconstruction plan remain, besides the publication of 2008 referred to above which does not state specifically that it describes the reconstruction of Musinga's Royal huts.

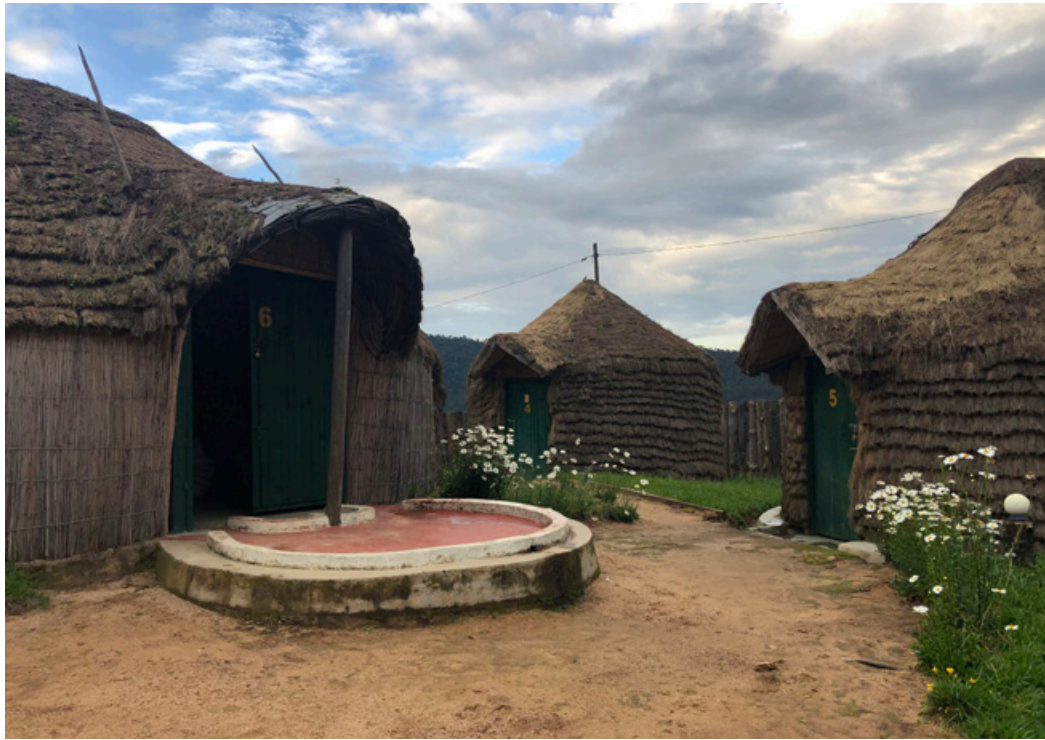
Fig. 24. Eco-lodges for tourism, inspired by the Royal huts in Rukari hill

However, an outcome of this reconstruction is the replication of the Royal huts for tourism development and attraction. For example, some eco-lodges were directly inspired by the Royal huts in Rukari hill (fig. 24) and were intended to recreate the traditional architecture so as to be attractive to the public. Clear authenticity issues arise, especially when the re-transmission of the source is also unclear. Hence, the replicating of the reconstructed Royal huts, without an understanding of the construction system and the sources could lead to the problematic transmission and interpretation of Rwandan vernacular architecture. Therefore, it would be important for the presentation and interpretation of the reconstructed heritage resources, that the history of the reconstruction and the re-assembling of different elements as heritage fragments are acknowledged and explained, as it is in this recount.

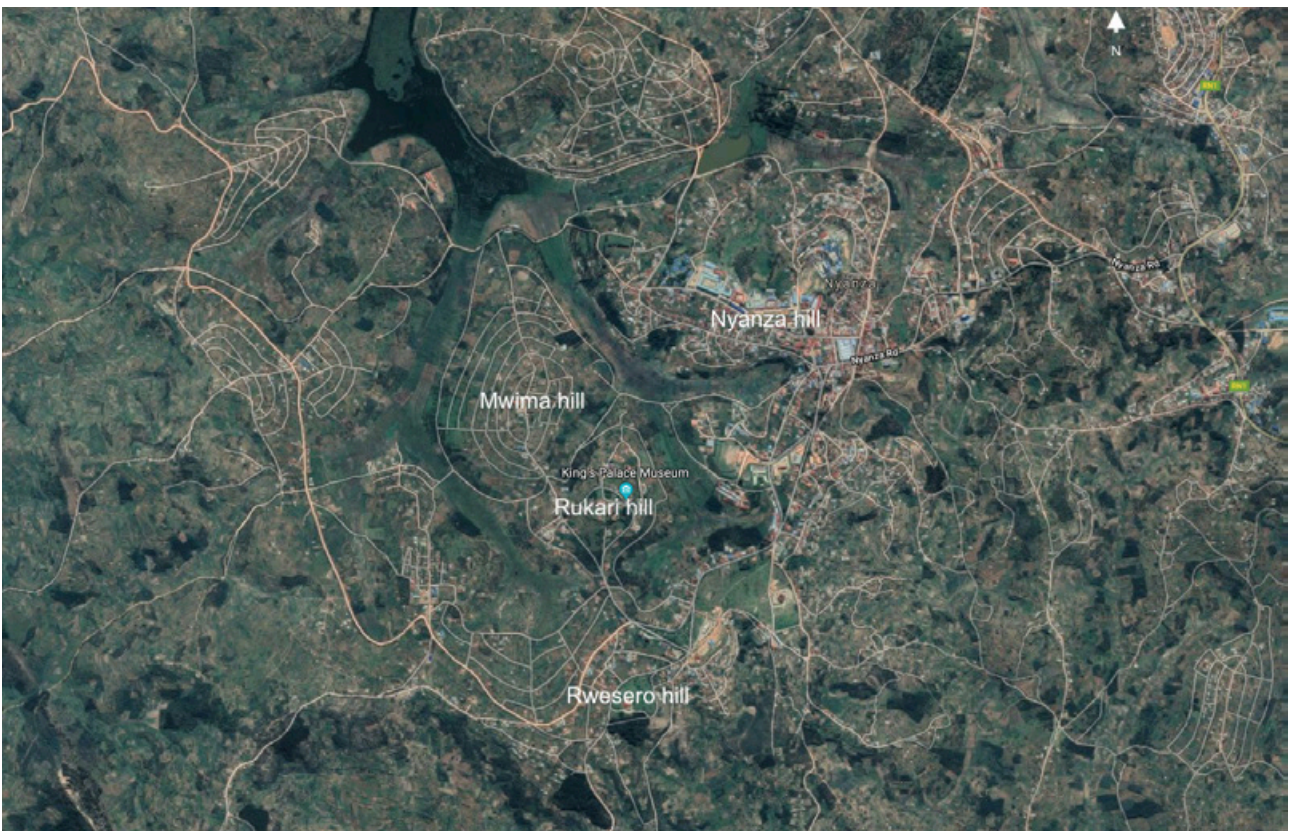
Map. 2. Map showing Rwesero, Rukari, Mwima, and Nyanza hills explains how the cultural landscape was organised in the past

Learning to read the Nyanza landscape could support the understanding of the history of Rwanda from the kingdom to the present. The hills of Rwesero, Rukari, Mwima, and Nyanza form a system that could be used to effectively explain to nationals and foreigners how the cultural landscape was organised in the past (Map 2). Together with the former site of the Royal Capital, where the sacred *ficus* stands and the church remains, these sacred sites, now cultural spaces, are connected visually and through their interrelations, narrate a piece of the history of Rwanda, which is little known. The creation of a cultural itinerary that would further connect this to the Nyanza Genocide Memorial, which commemorates the approximately 12,000 people that were killed in the school that stood on the site, and the *Imidugudu* in Rwesero, (fig. 25) would support further the transmission of the evolution of Rwanda's landscape.

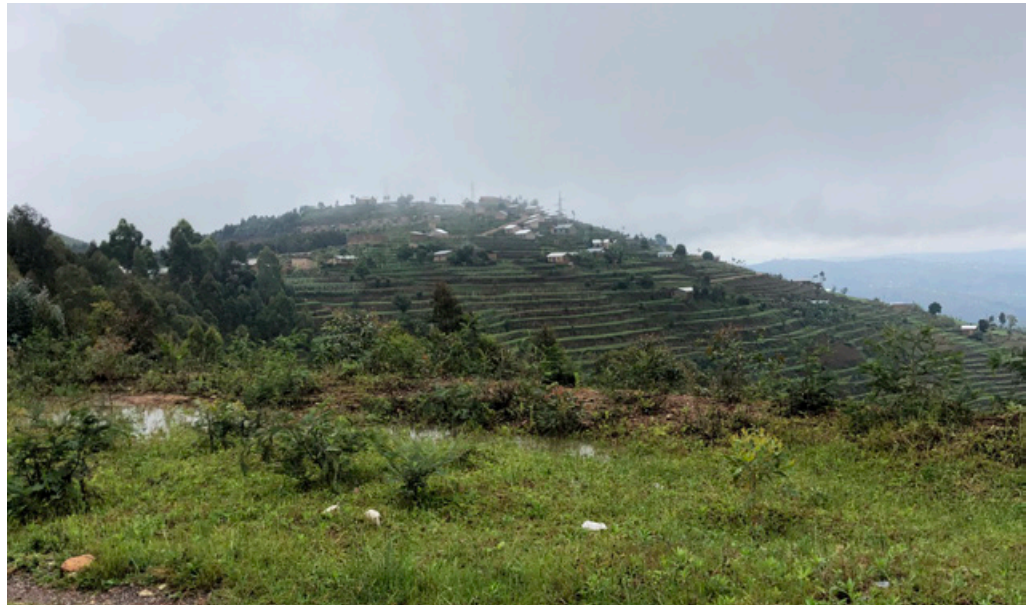
Fig. 26. Terraces in the hills

which are historical remnants still appreciated in the present (fig. 26). Furthermore, reconsidering and valuing both the agricultural and pastoralist landscapes, including agroforestry, would also contribute to avoiding soil erosion and retaining water, issues of utmost relevance in the face of climate change, and the degradation of Rwandan agricultural land. The hill system represented a holistic system of adapting to the geographic conditions, considering not only cultural, social, but mostly environmental conditions. So far, in this reconstruction project, attention has not been paid to the hill system, focusing only on the reconstruction of pieces of it. To reinforce the interrelations found in the hill system, acknowledging the interdependence between the different landscape practices could potentially contribute to the building of a stronger path for reconciliation.

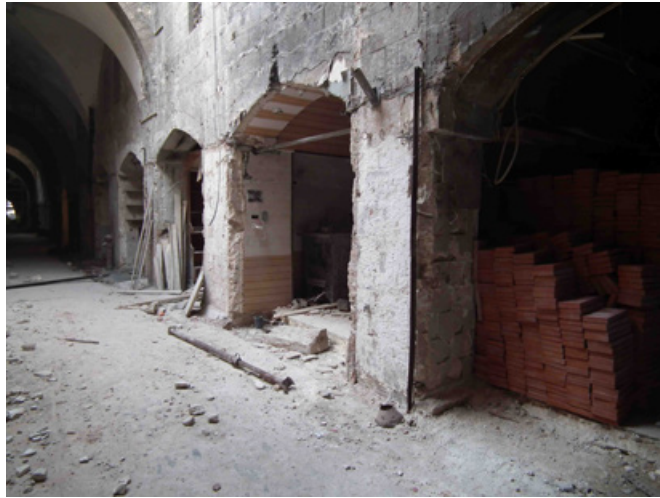
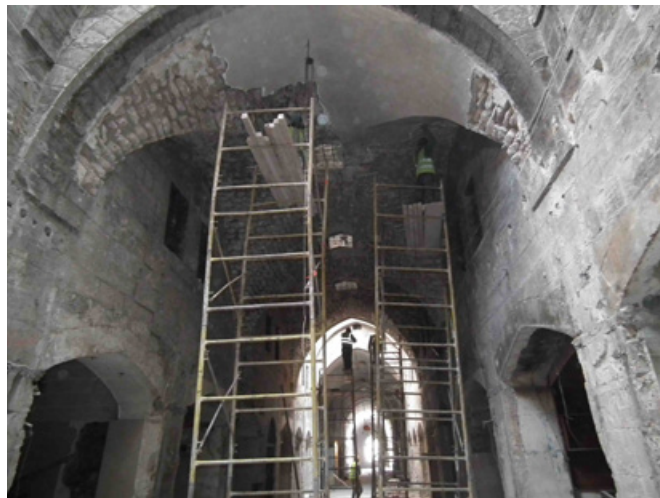
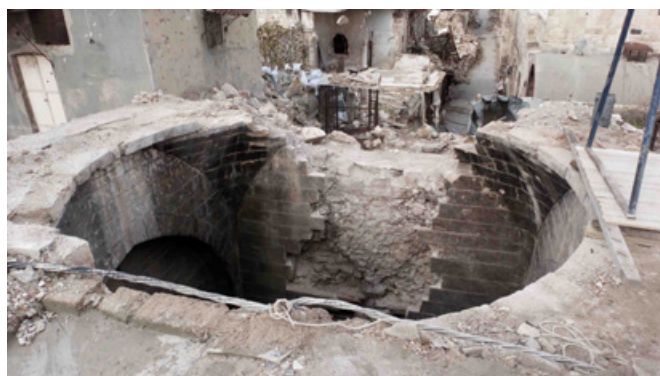
Fig. 8. The installation of support scaffolding for the destroyed and disintegrated sections, (courtesy of DGAM)

and installations and handing them to their owners (fig. 9). Within this phase, some of the upper windows that had been blocked up were re-opened after negotiations with the shopkeepers. The worn joints were purged and the cracking screeds of the upper roof and the flaking plasters were removed (fig. 10). The removal works were done manually as much as possible to minimise additional damage to the original materials.

b. Reconstructing the destroyed sections: The destroyed sections were rebuilt following the traditional local techniques and using the remaining usable materials in addition to new ones when needed. The new bricks were fabricated following the same dimensions and specifications of the original ones. The stone blocks were chosen to be as geologically similar to the original ones as far as possible. They were dressed using the same traditional tools and techniques. One of the partially destroyed domes was completely dismantled and rebuilt together with destroyed sections of its supporting walls and pendentives in order to ensure its structural stability (fig. 11).

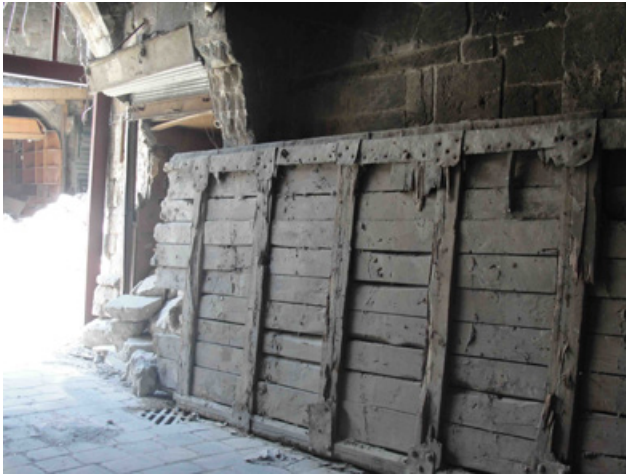
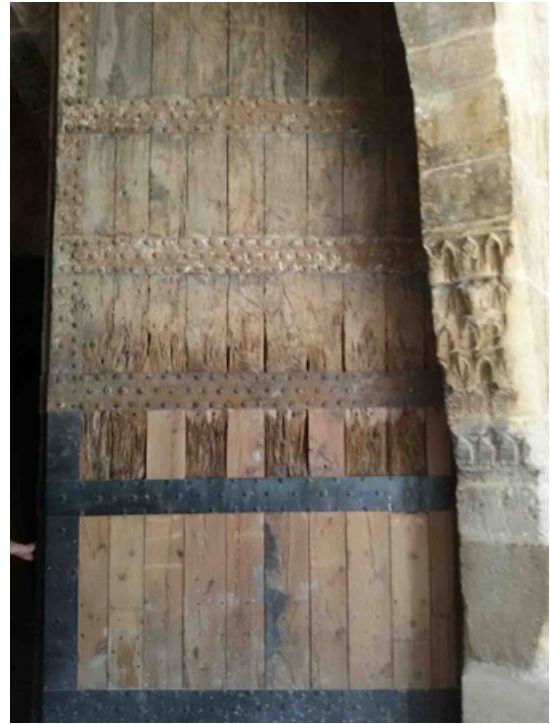
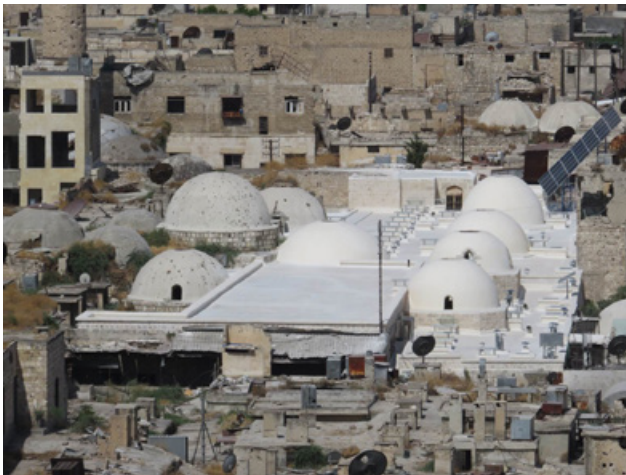
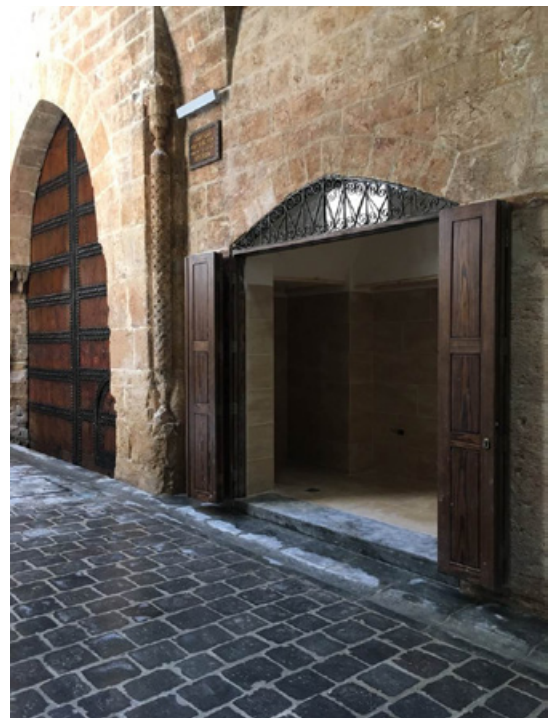
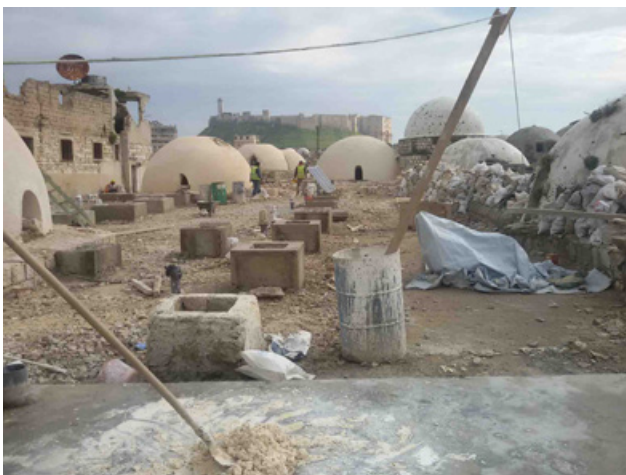
Fig. 13. The western wooden door of the suq before and after restoration, (courtesy of DGAM)

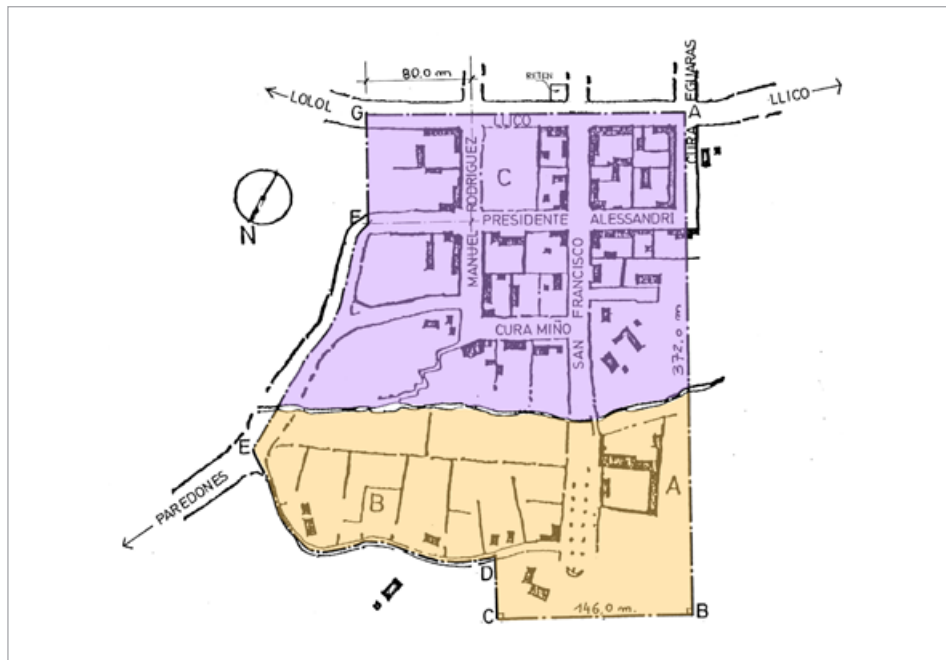
►
From top to bottom:
Fig. 7. Map of the boundaries of the Typical Area of San Pedro de Alcántara, showing the two main areas of development: the foundational area (yellow) and the "new town" built after the 1900 flood (purple). (Author, based on the original drawing from the land deed of 1690, with boundaries drawn by CMN in 1996)
Fig. 8. Map of the three touristic trails created by the Ministry of National Assets (MBN) based on what is believed were the routes of the Royal Roads *Camino de la Costa* (coastal road) in red; *Camino del Centro* (centre road) in purple; and *Camino de la Frontera* (frontier road) in orange. (Author, based on data from the MBN, 2019)

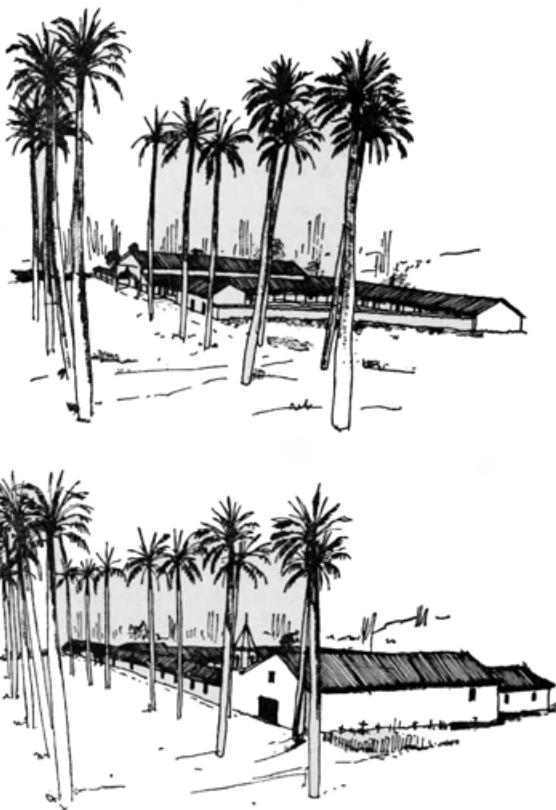
Fig. 9. (top) View of the current church from the grotto. (bottom) View of the original church from the grotto. Drawings based on historic data collected by Claudio Ferrari for the article "El Convento Franciscano de San Pedro de Alcántara en el Siglo XVIII y Comienzos del Siglo XIX", *Revista Historia*, 1970

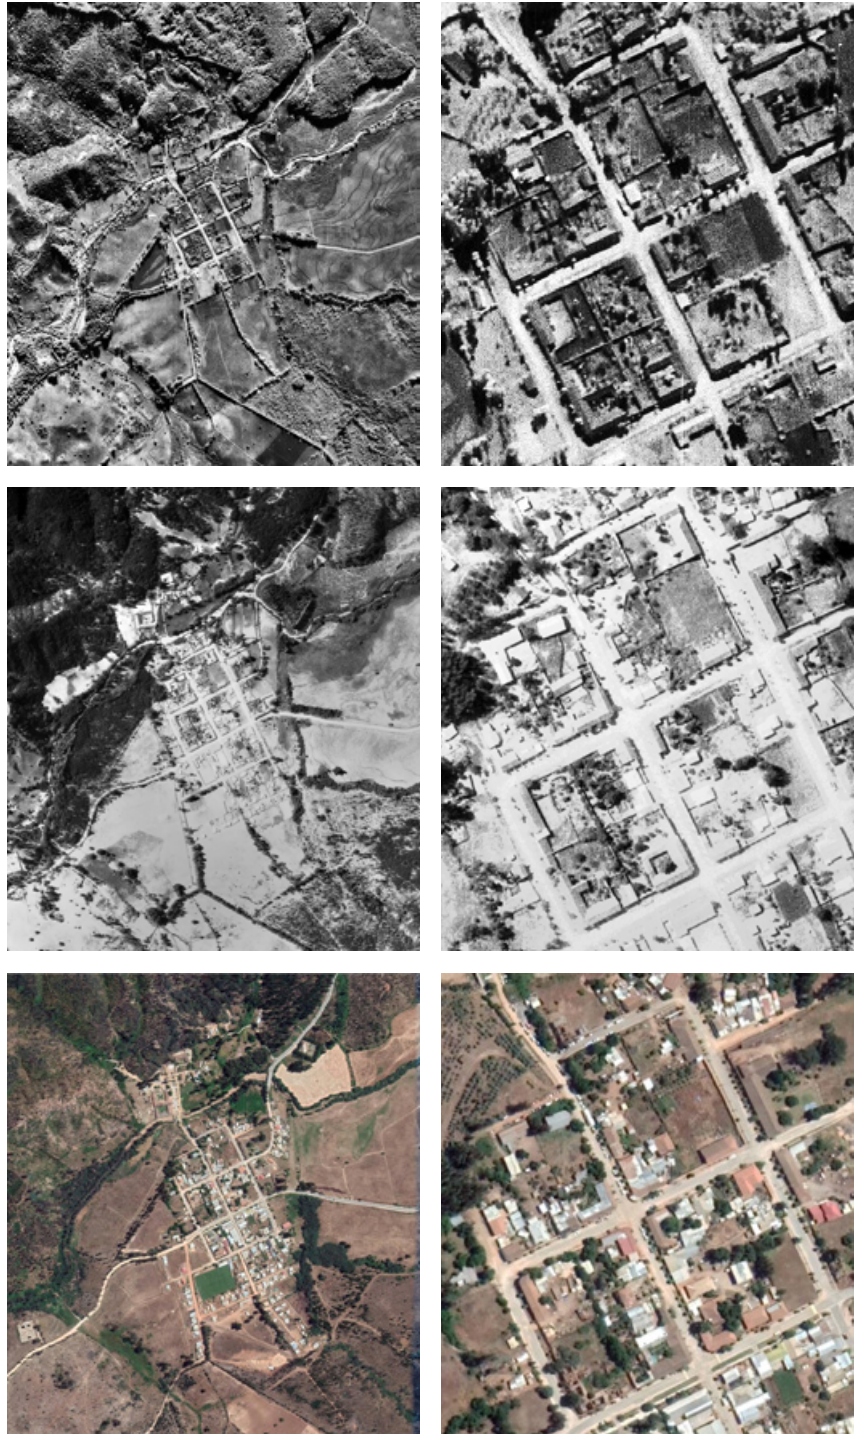
► **Figg. 10–12.** Aerial views of San Pedro de Alcántara in 1978, 1994, and in 2019, zooming into the central blocks of the town. Blocks remained mostly unchanged after the 1985 earthquake, but considerable changes can be seen in block composition after the 2010 earthquake, with several buildings disappearing. (courtesy of Servicio Aerofotogramétrico de Chile)

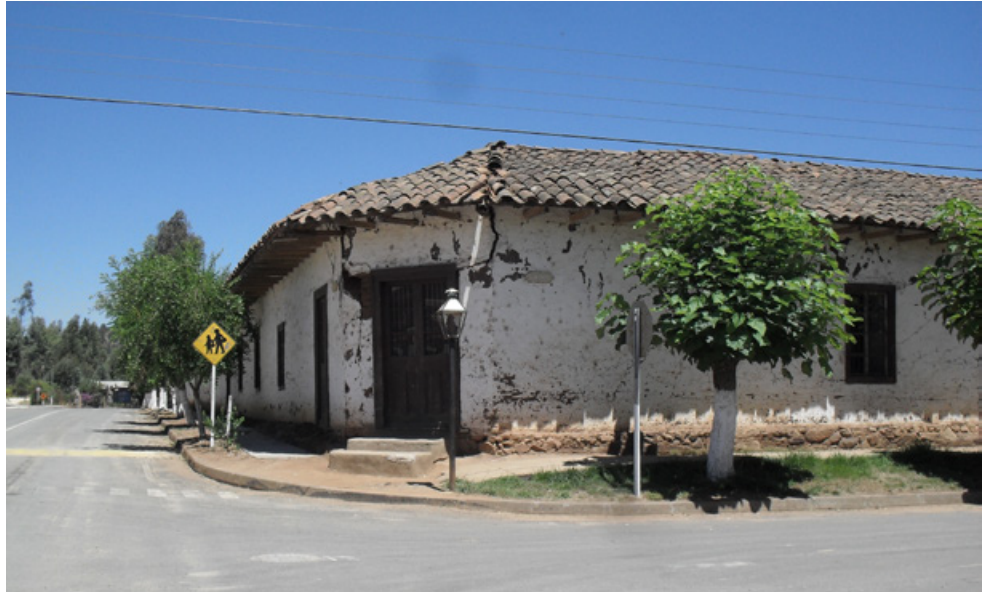
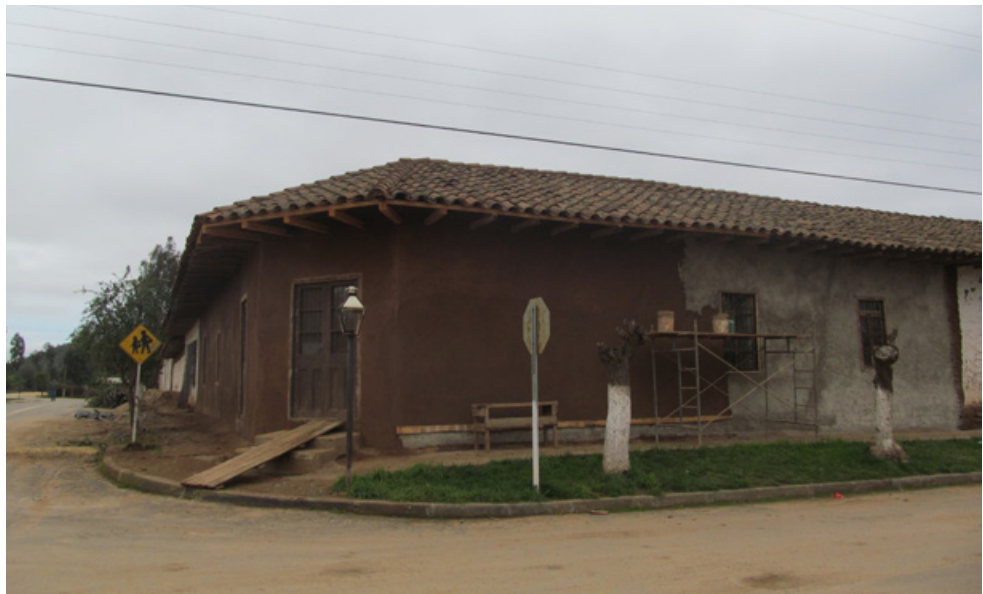
►
From top to bottom:
Fig. 32-33
 View of Ive Correa's house, located in the corner of Llico and San Francisco Streets, before the earthquake and during construction. (courtesy of MINVU)
