ANALYSIS OF CASE STUDIES IN
RECOVERY AND RECONSTRUCTION

CASE STUDIES

Patan, Nepal • Taishun, China • Nyanza, Rwanda
Aleppo, Syria • San Pedro de Alcántara, O'Higgins Region, Chile
WH Cultural Landscape Wachau, Austria • San Luis Potosí, México

VOL. 2

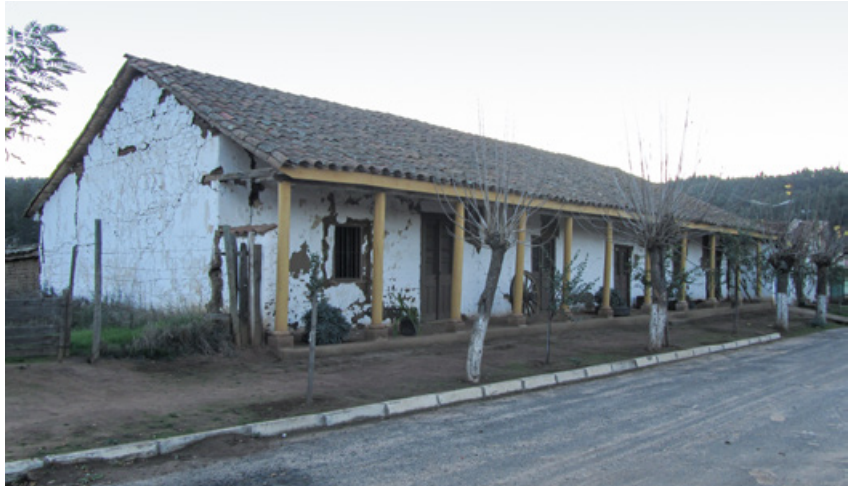
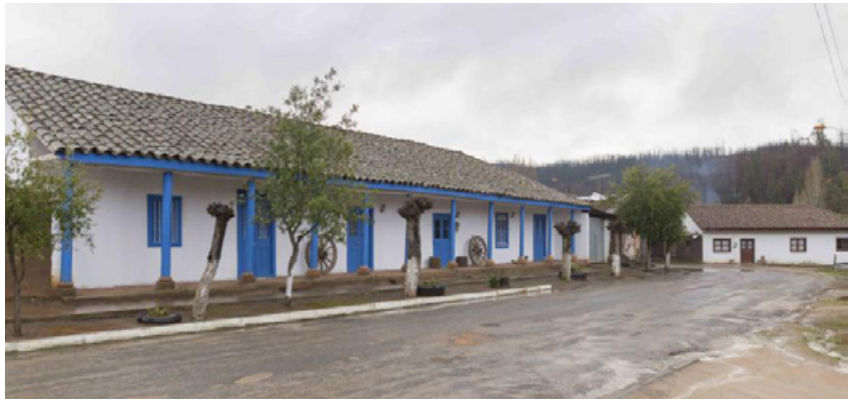
►
From top to bottom:
Fig. 37–38 View of Leonardo Peñaloza’s house in Manuel Rodríguez Street, before and after repairs were completed. (courtesy of UChile and CMN)

When evaluating the experience, most of the owners see it as positive, especially for those who maintained a good relationship with the consultants and were able to make adjustments during the construction phase (fig. 37–38).

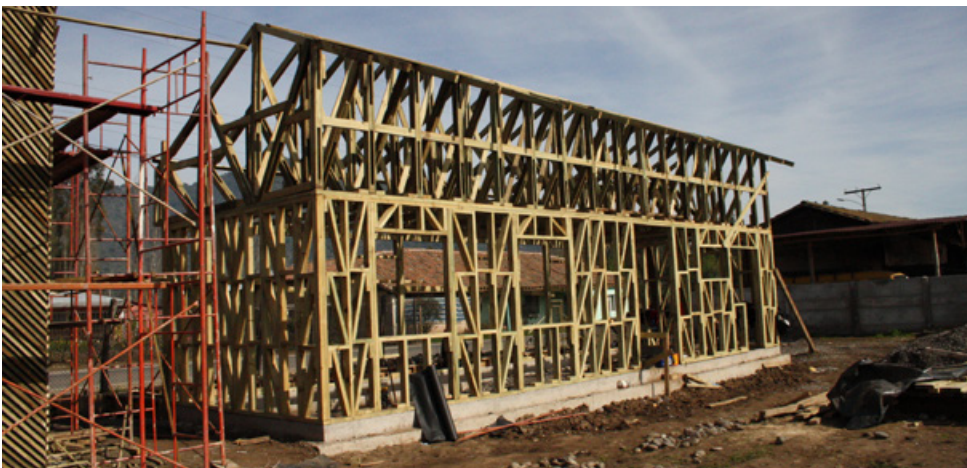
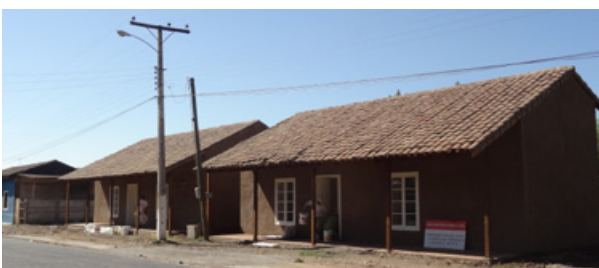
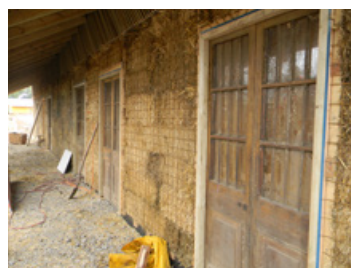
Construction process of one of the new houses designed by Larrain & Rodway Architects in Chepica. (courtesy of SEREMI MINVU, 2011)

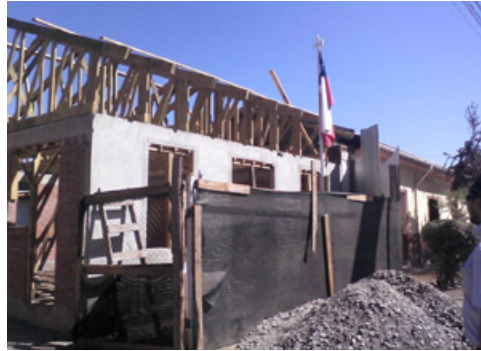
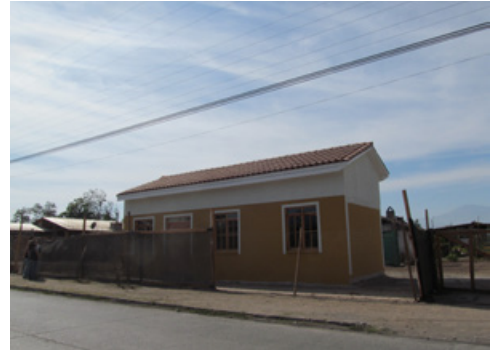
Fig. 42-43

Construction process of one of the new houses designed by Miguel Galvez Engineering & Builders in Miraflores Street, Chimbarongo commune. (courtesy of SEREMI MINVU, 2012)

The design reproduced the architectural features of typical adobe houses in the street and used finishes that resembled traditional materials (figg. 42–43). It also included the design for an expansion that completed the continuous façade, typical of this area. Despite not being an “ideal” solution, this case proved that builders have the capacity to develop designs that take into consideration their context. Homeowners were an active part of the process and celebrated together every time a house was finished.

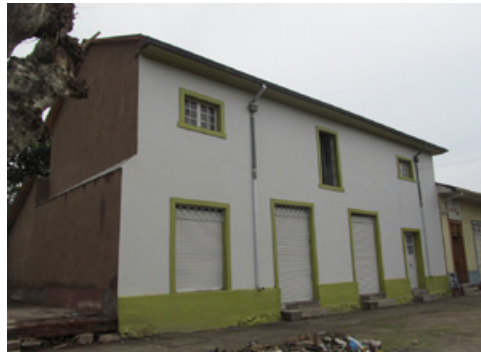
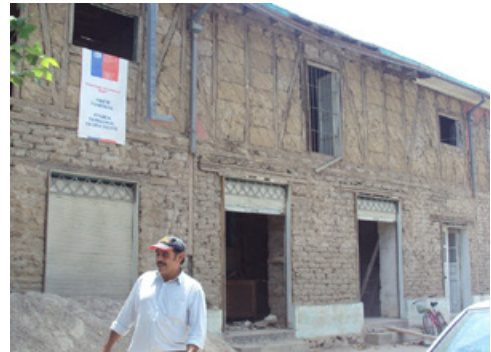
Fig. 44-45

Construction process in one of the houses restored by Altiplano Foundation in Peralillo. (courtesy of SEREMI MINVU, 2012)

- In the Peralillo commune, one of the consultants hired to develop seismic retrofitting projects was the *Altiplano* Foundation. This organisation had ample experience working with churches in the Arica region, specialising in the use of Biaxial Polypropylene Geogrid as reinforcement for adobe walls. In Peralillo, they developed eight projects using this technique, also implementing their "school-workshop" methodology which prioritised hiring community members and using each project as a training opportunity for them, thus increasing local capacity (figg. 44-45).

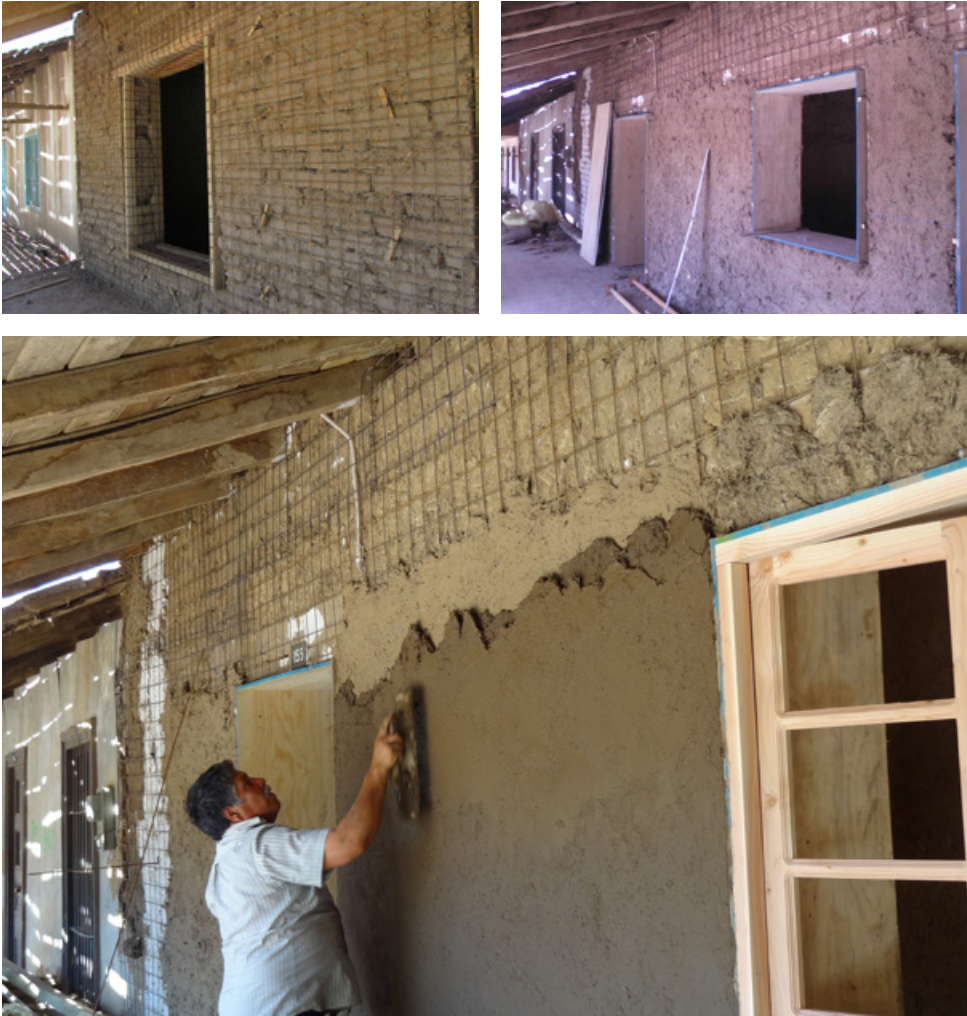
Example of the process of installing electro-welded mesh as reinforcement for adobe houses of the town of Lolol. (courtesy of SEREMI MINVU, 2013)

As for reinforcement solutions, the town's distance from large cities made it necessary to use materials that were available in most hardware depots on a regular basis, since "buying in bulk" was not an option for homeowners or small local contractors. The most utilised material was electro-welded mesh – used commonly for reinforced concrete walls, floors, foundations, etc. – which is easy to transport, store and install.

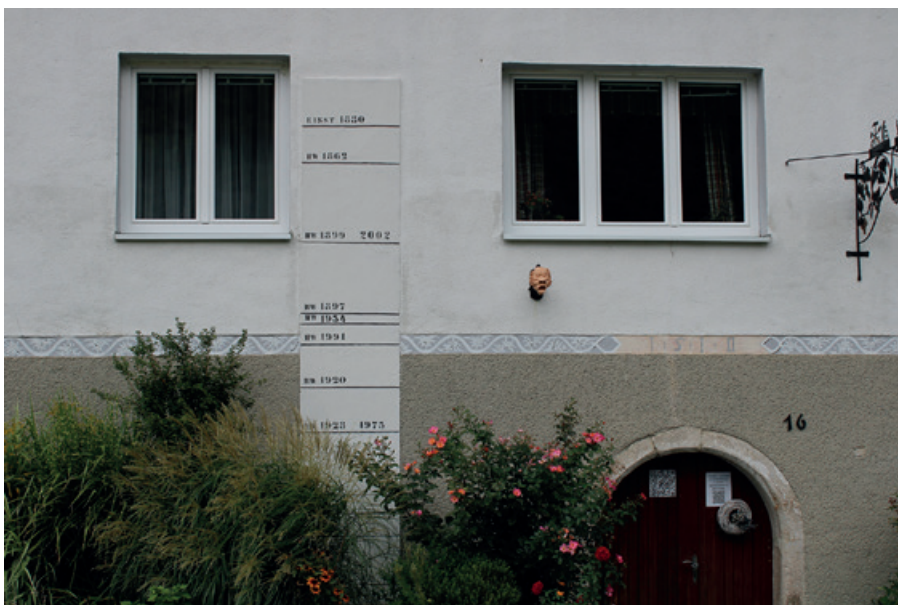
◀ **Fig. 2.** M. Schimek, 2019, Flood marks at the house Oberarnsdorf 16

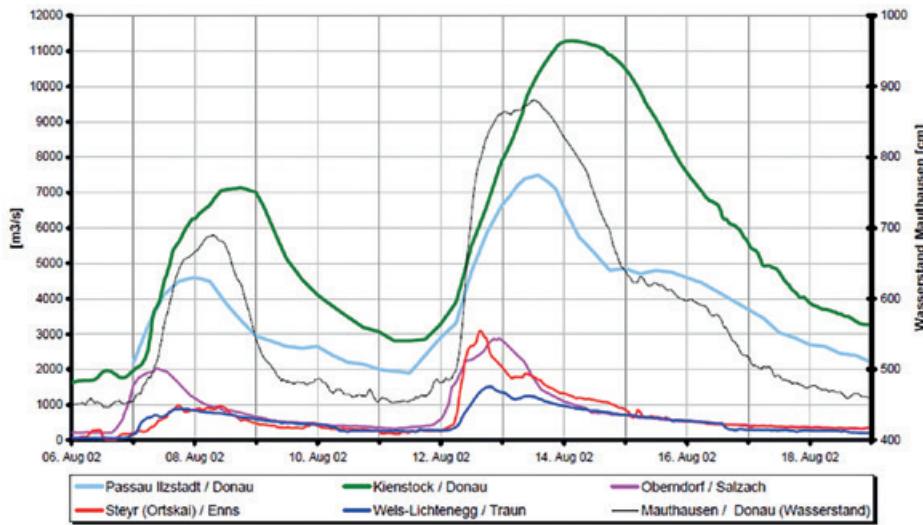
◀
From top to bottom:
Fig. 4. The August 2002 flood on the Danube, in: Godina *et al.* 2004, 32
Fig. 5. Flood levels in August 2002 from the Wachau downwards, in: Godina *et al.* 2004, 33

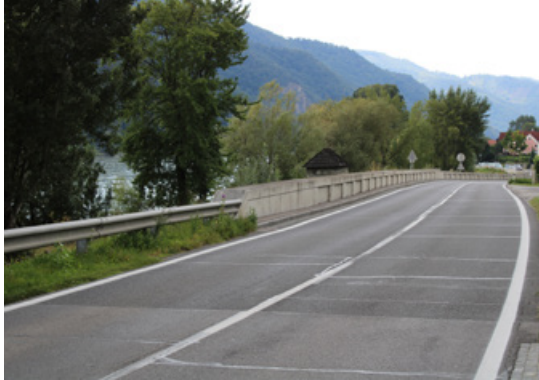
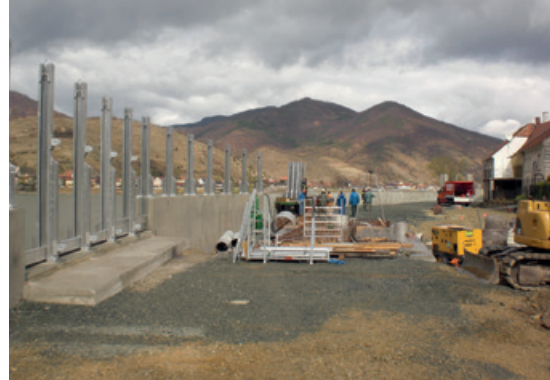
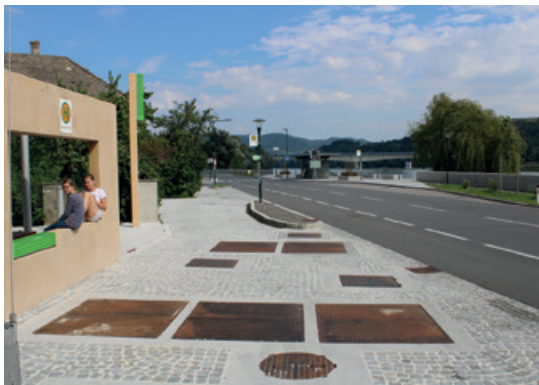
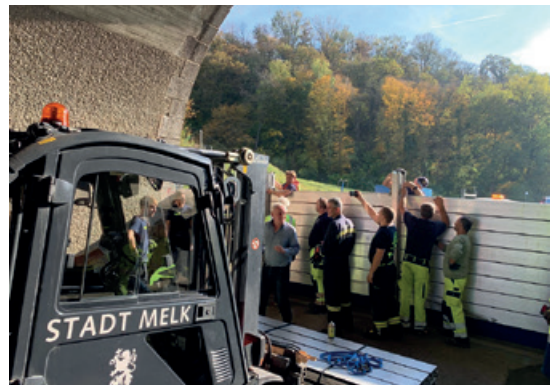
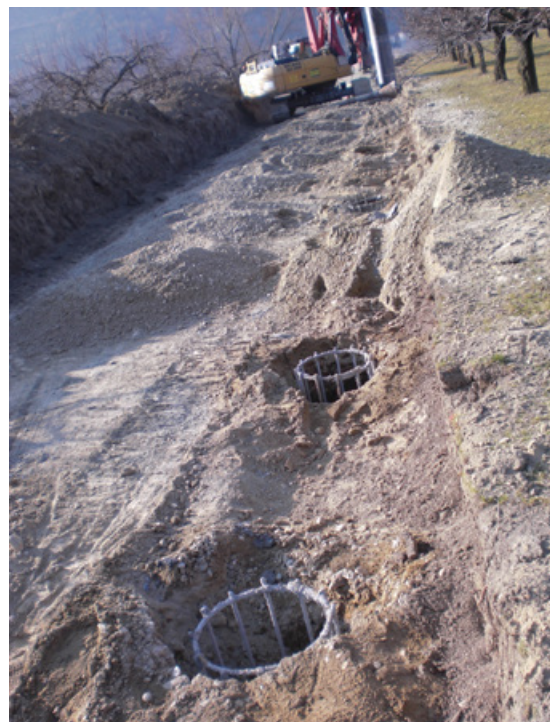
▲
Images, Clockwise from top left:
Fig. 8. M. Schimek, 2019,
 The base walls of the flood
 protection systems should about
 equal the height of the guard
 rails along the main road
Fig. 9. R. Schütz, 2012, Trial
 mounting of the flood protection
 system at Oberarnsdorf
Fig. 10. P. Strobl, 2019,
 Trial mounting of the flood
 protection system near Melk
Fig. 11. R. Schütz, 2011, Grounding
 of the walls near Rührsdorf
Fig. 12. M. Schimek, 2019, Location
 of the pump house at Emmersdorf

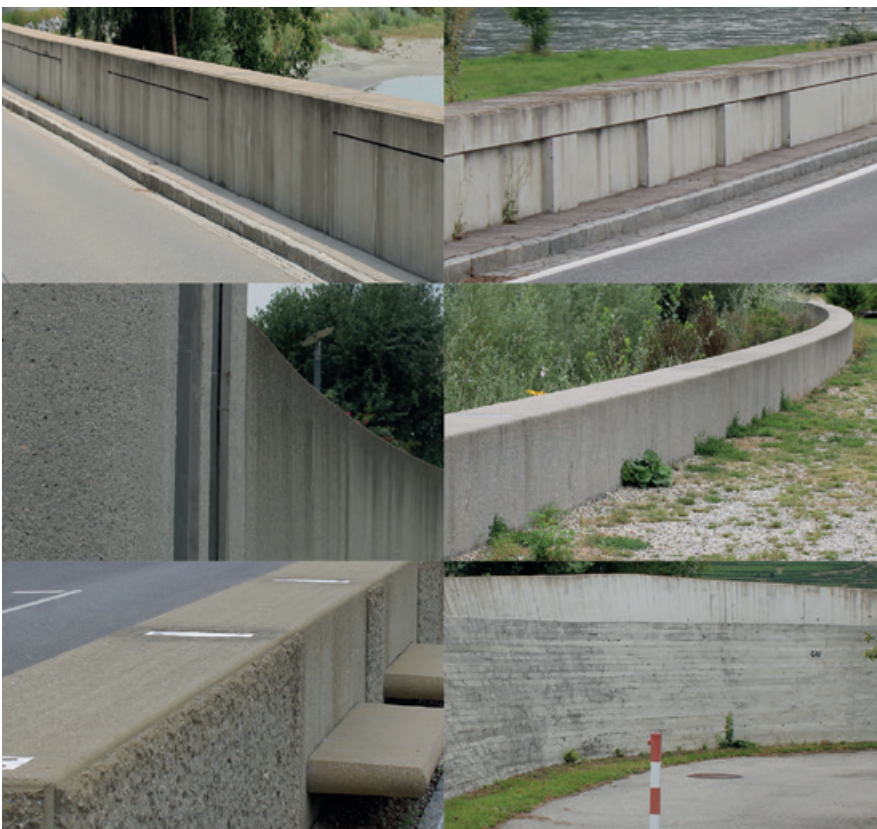
◀ **Fig. 13.** M. Schimek, 2019, Different wall designs

As for the design of the walls, the decision was taken that they should be recognisable as a twenty-first-century intervention and not be designed in a historicising manner. This led to different aesthetic solutions, though, depending on which architect the municipality chose for the job (fig. 13).

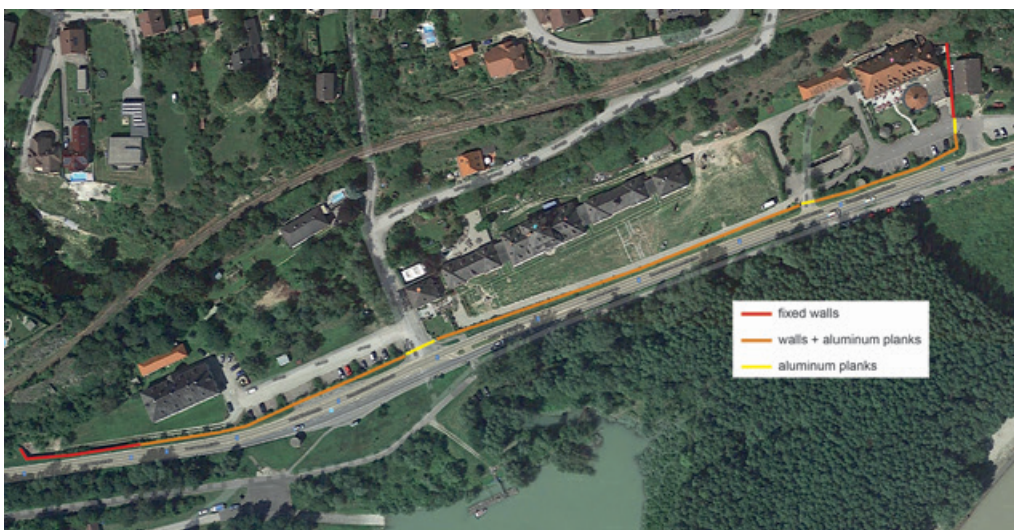
◀
Fig. 14. Google Maps, cartography M. Schimek, 2019, Flood protection system at Luberegg

The aluminium panels are privately stored and mounted in case of emergency. The system was finished in 2006.²⁰ The whole infrastructure is about 500 m long.²¹

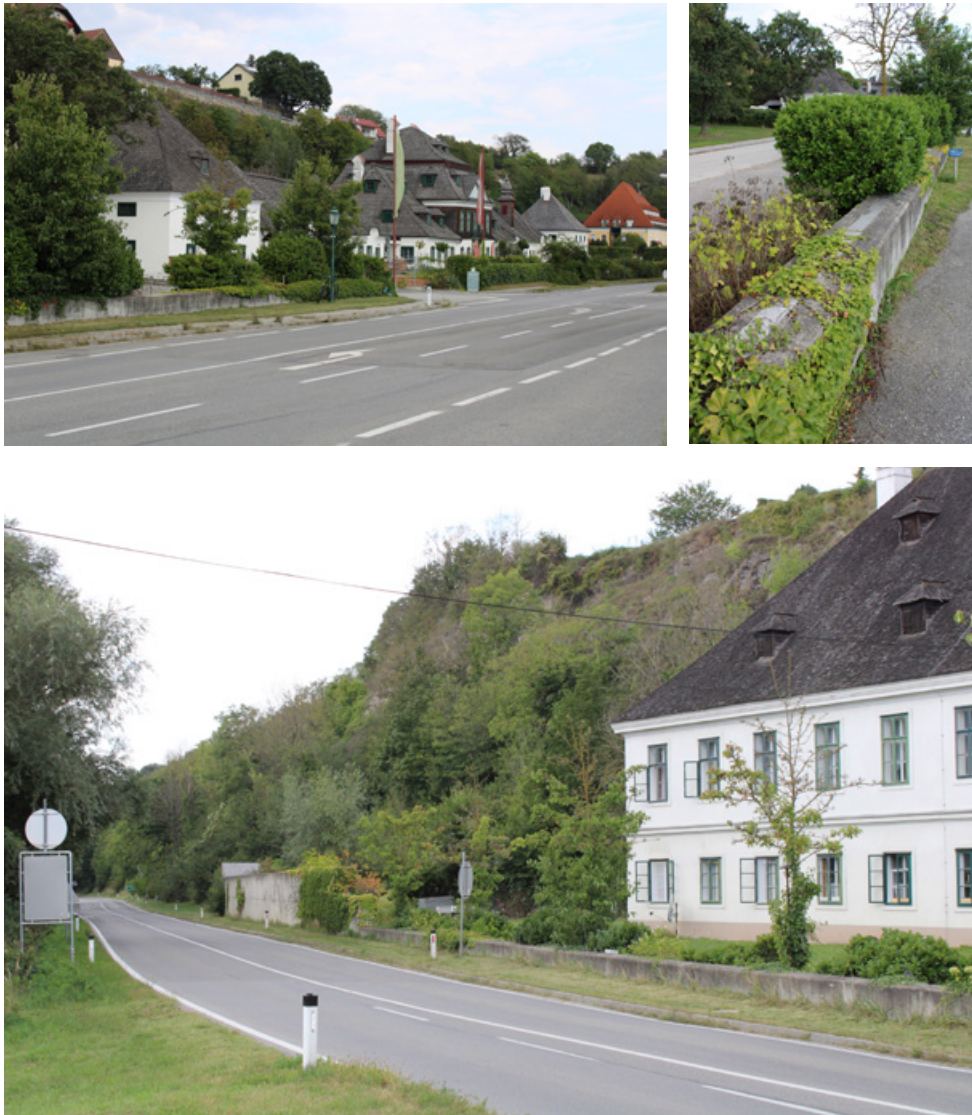
Fig. 15. M. Schimek, 2019, Luberegg castle and the flood protection wall

protection systems later (fig. 15), in this case replacing the garden walls of the castle by a low concrete wall on which aluminium panels can be screwed for the final height of the system (fig. 16). Only in the westernmost corner and to the side of the already existing Landhof Hotel were higher walls erected (fig. 17).

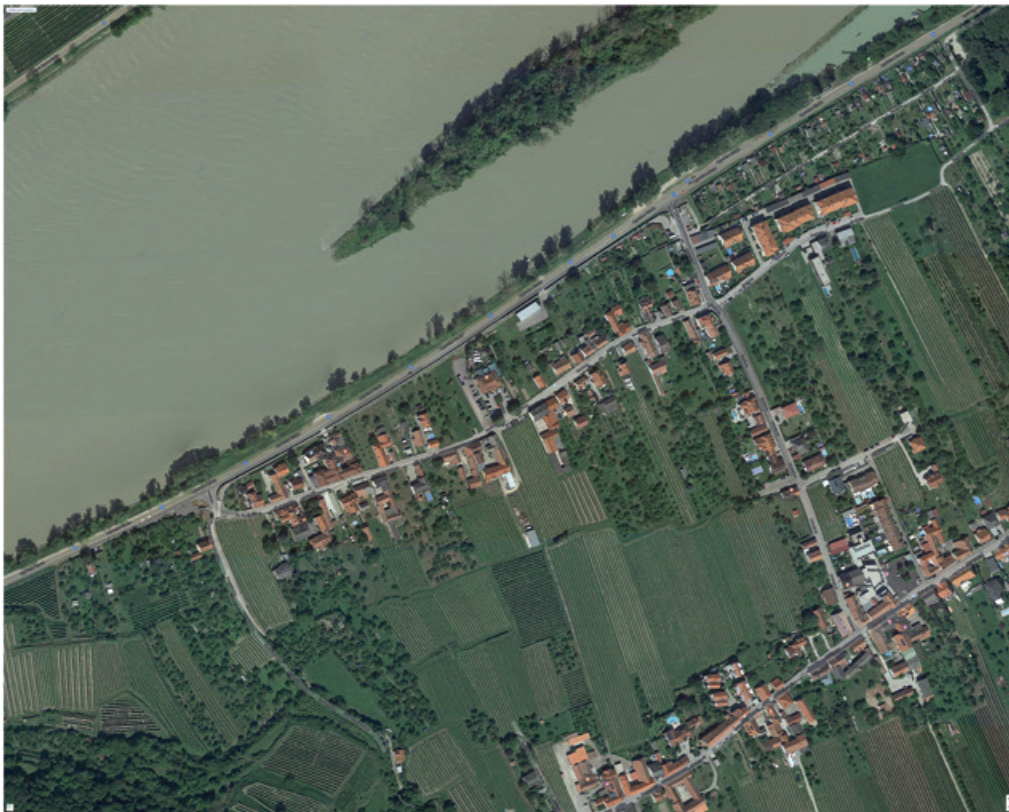
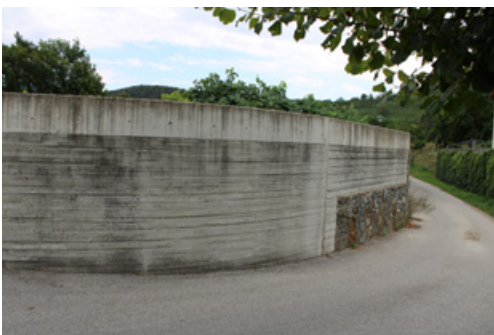
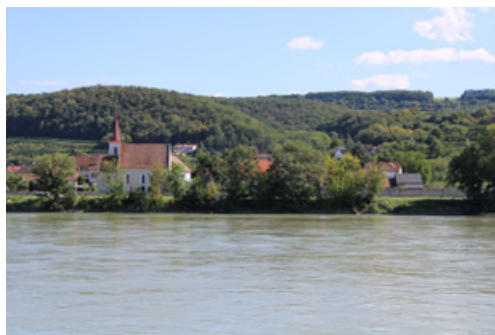
Fig. 18. Google Maps, cartography M. Schimek, 2019, Flood protection system at Hundsheim

Fig. 19. M. Schimek, 2019, Hundsheim chapel and the flood protection solution around

Fig. 20. M. Schimek, 2019, Upper corner of the flood protection at Hundsheim

The small village of Hundsheim belongs to the town of Mautern, opposite the town of Krems-Stein. In this case, the municipality council of Mautern started their plans to build a flood protection system without discussing it with the regional board. Thus, everybody was very surprised when they presented a draft which planned to build only fixed walls, most of them 3 to 5 m high.

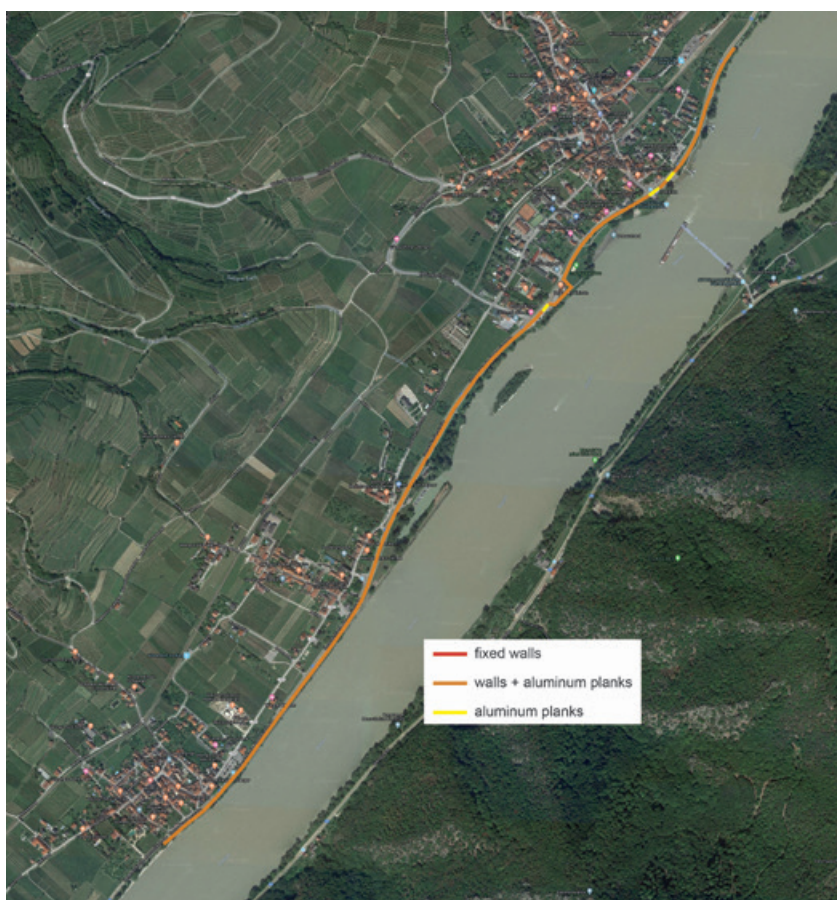
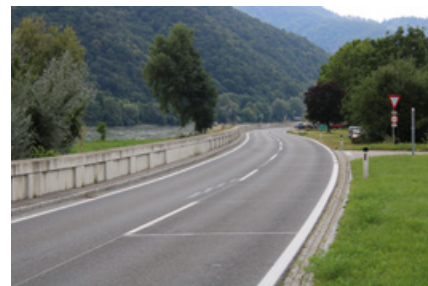
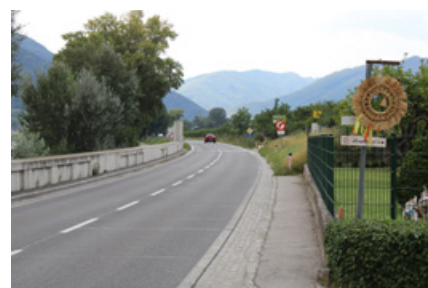
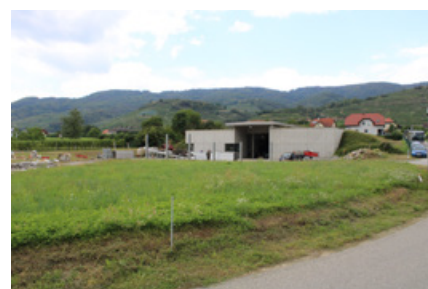
Fig. 21. Google Maps, cartography M. Schimek, 2019, Flood protection system at Weißenkirchen, Joching, and Wösendorf

Because of this design method, the whole system only requires a single, relatively small flood gate at Wösendorf (fig. 23). At the other end, in Weißenkirchen, the street rises high enough so that the wall can simply end there.

A very good solution could be found for the enormous storage capacity that is needed for the aluminium panels. A new storage hall was erected between Wösendorf and Joching. It is not visible from the main road and is built into the wine hills, thus only a relatively small front stands out into the landscape and most of the building is hidden (fig. 24).

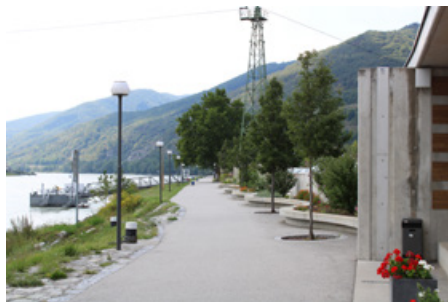
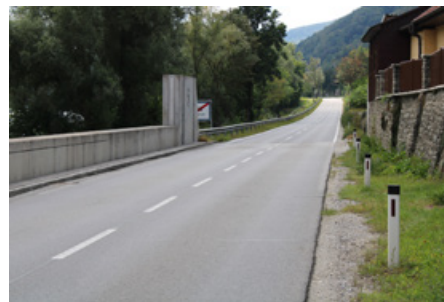
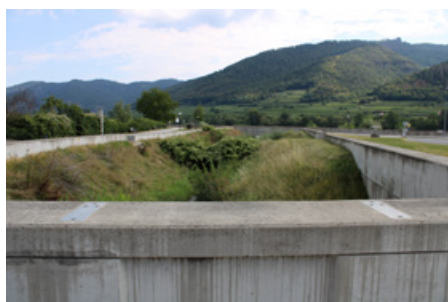
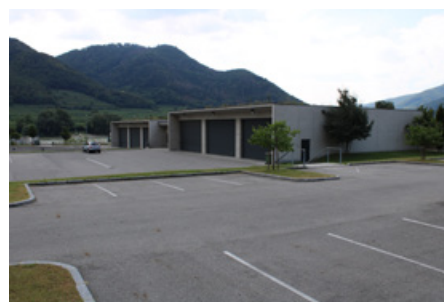
▲
Images, Clockwise from top left:
Fig. 25. Google Maps, cartography M. Schimek, 2019, Flood protection system at Spitz
Fig. 26. M. Schimek, 2019, The double planked flood gate at Hinterhaus
Fig. 27. M. Schimek, 2019, Storage halls at Spitz
Fig. 28. M. Schimek, 2019, Flood walls surrounding the Spitzer Bach mouth
Fig. 29. M. Schimek, 2019, New design of the Spitz landing

from the Danube, but then the municipality managed to acquire a plot of land near the Mieslingbach, at the lower entrance to the village, and decided to relocate the storage halls without further discussion (fig. 27). ICOMOS Austria reported its disagreement with the solution but had to accept the majority decision of the advisory board. No further action was taken by the World Heritage committee.

Another particular element of the flood protection system is the mouth of the Spitzer Bach creek, the largest tributary in the inner Wachau, which had to be made safe as well. This is why in addition to the walls near the Danube, another circular wall had to be built around the creek. In this case also, a decision was taken to use the wall-aluminium panel solution (fig. 28).

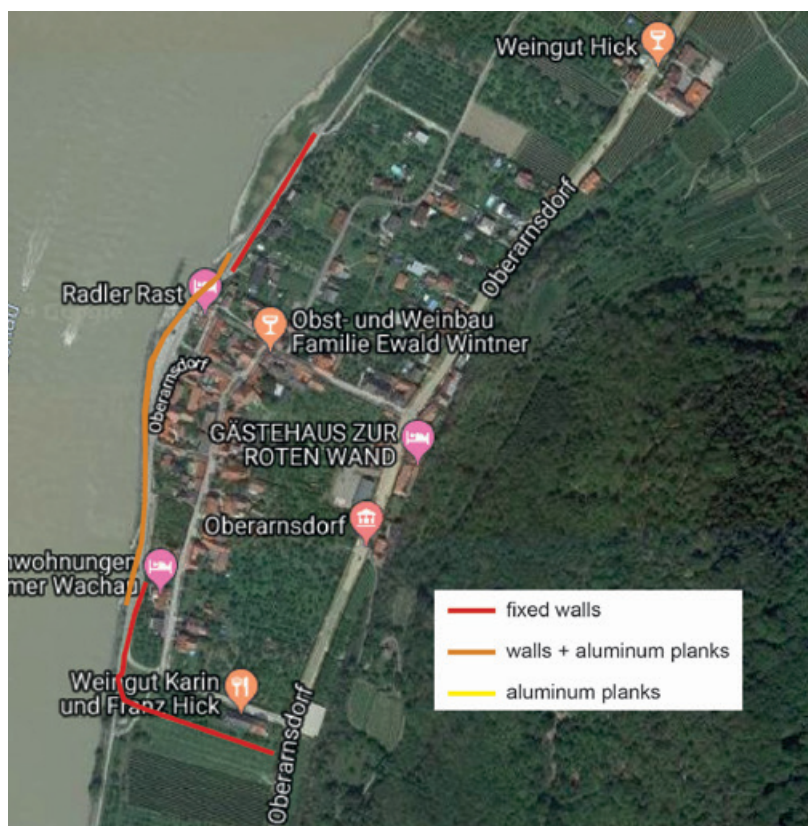
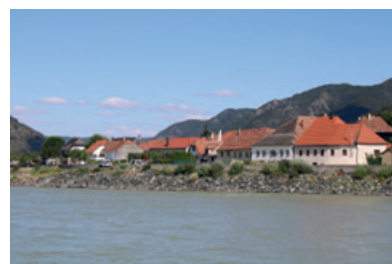
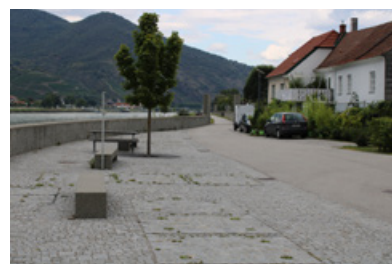
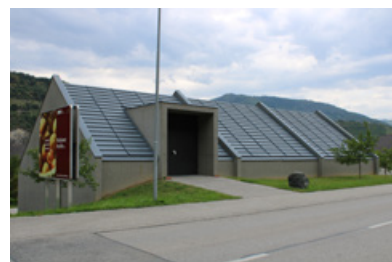
Fig. 30. Google Maps, cartography M. Schimek, 2019, Flood protection system at Oberarnsdorf

Fig. 33. M. Schimek, 2019, Storage hall seen from the main road

The storage facility for the aluminium panels was located in the backyard of one of the old village houses. It was built into a steep gradient from the main road, so that the building looks modest from the street side (fig. 33). The real extent is only visible when driving down the hill – this view is obstructed from the village and the Danube, though, so it does not have any impact on the visibility of the World Heritage site.

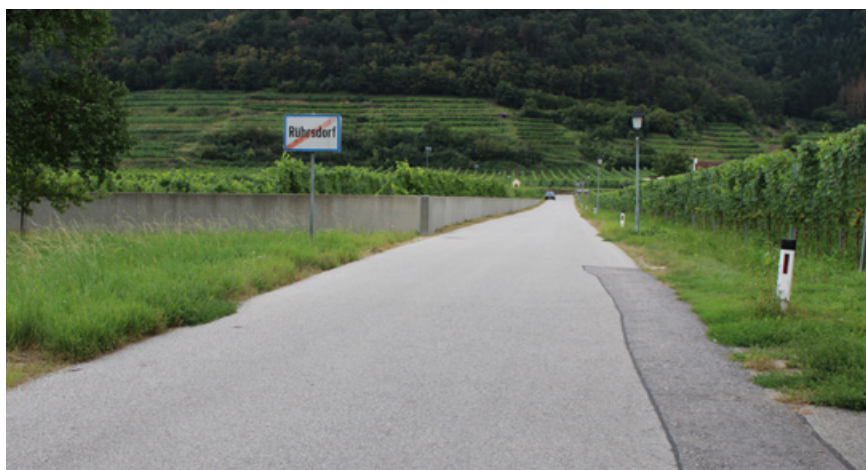
Fig. 35. M. Schimek, 2019, Walls are needed deep into the vineyards because of the flat land surrounding Rührsdorf

part of the structure using the wall-aluminium scheme. At the northern end of the structure, an existing dam was used to keep the waters away and this was supplemented by a fixed wall in the vineyards. East of the village rather high walls are needed because of the flat nature of the land surrounding the village (fig. 35).

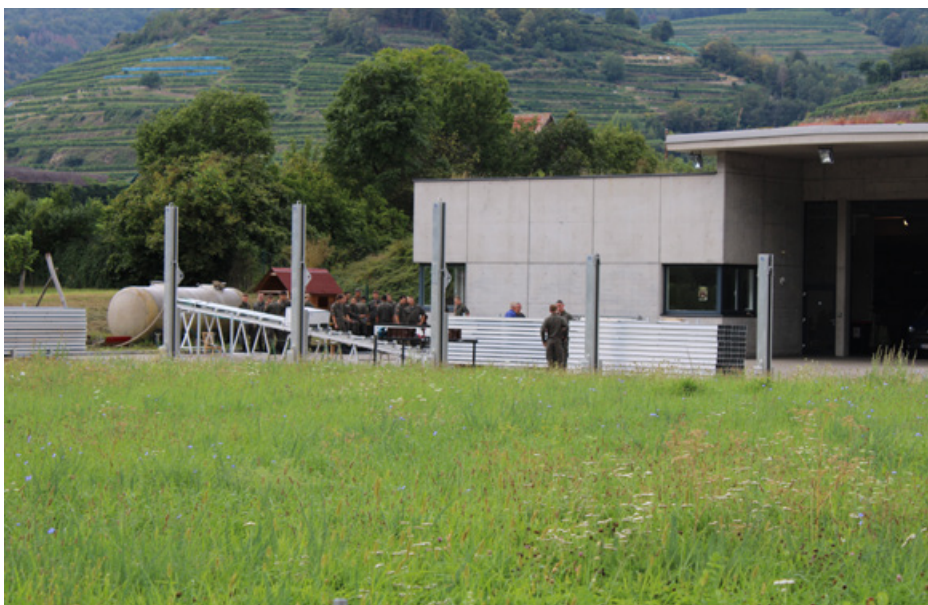
Fig. 36. M. Schimek, 2019, Aluminum plank washing machine at work during a practice with the Austrian army in Weißkirchen

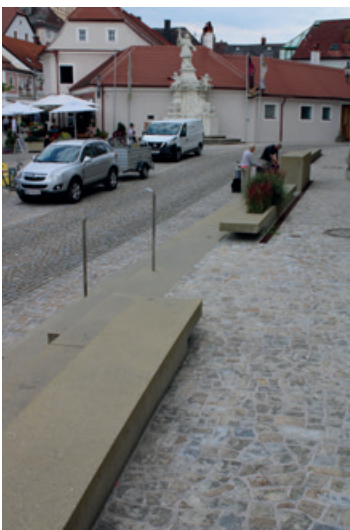
◀
From left to right:
Fig. 38. M. Schimek, 2019, Design elements along the main square in Melk
Fig. 39. M. Schimek, 2019, The "World Heritage Lens" enhances the visibility of the baroque abbey from the Danube landing

Cables and canal were renewed underground, car traffic and parking were reduced, asphalted street surfaces were replaced by cobblestone, and the main square was turned into a "meeting point"⁴⁹ which can be used in multiple ways for events, presentations and cultural purposes (fig. 38). A special feature implemented is the so-called "World Heritage Lens", a platform partly built above the water providing visitors to the city with an improved viewpoint to the front of the baroque abbey (fig. 39). The lens was additionally funded from the World Heritage budget of the republic in order to ensure that the protection system is more aligned with the World Heritage status of the city.⁵⁰

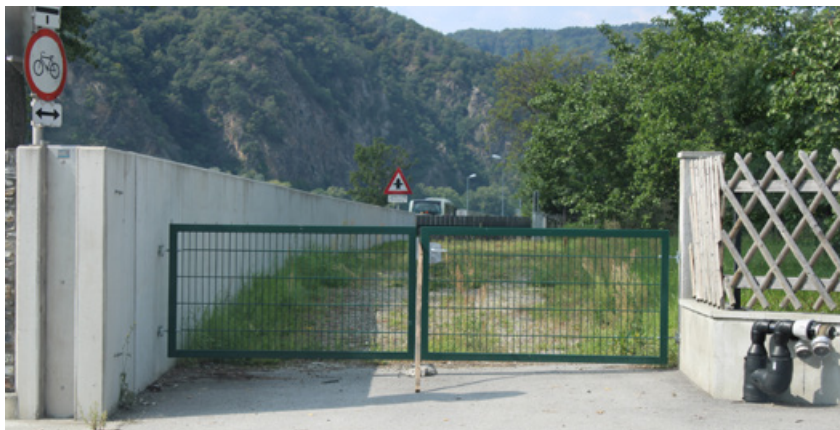
Fig. 40. M. Schimek, 2019, Emergency lane at Unterloiben

further away from the Danube. This is why they agreed on an emergency lane to be built inside the walls on their land (fig. 40), which allowed the municipality to follow the usual concept of walls and aluminium panels, though on higher base walls than usual, since the wall was integrated into an existing vineyard wall at the lower end of the village.

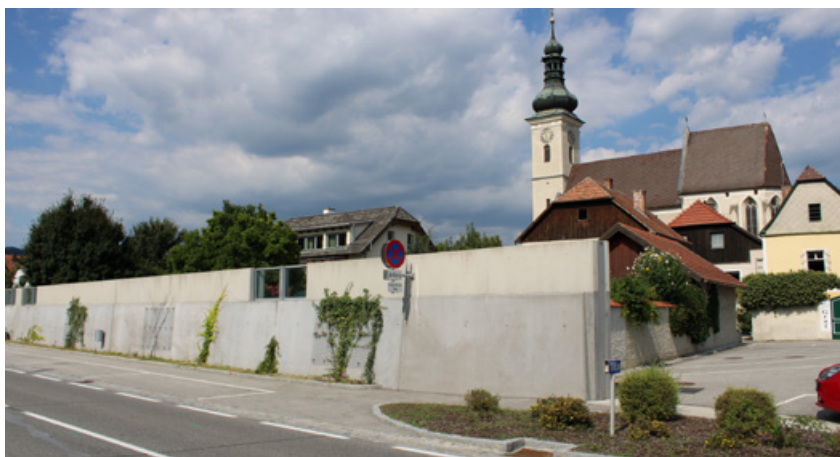
Fig. 41. M. Schimek, 2019, Massive walls at the upstream part of the flood protection in Unterloiben

Upstream from the parish church, there was less space between the road and the houses, so here the whole protection was built as a very tall wall, which led to a lot of public discussion. People had forgotten, though, that there had been a similar wall here previously, but because it was overgrown with ivy it had not been perceived as a tall wall. The new wall was in fact, only about a metre higher than the previous one, which was clearly marked out by the new design (fig. 41). It was agreed that the new wall would also be covered with vegetation. However, the new bushes were planted in the extremely hot summer of 2015, and not all of them survived, so it will probably take a bit more time before the wall looks as it did before 2013.

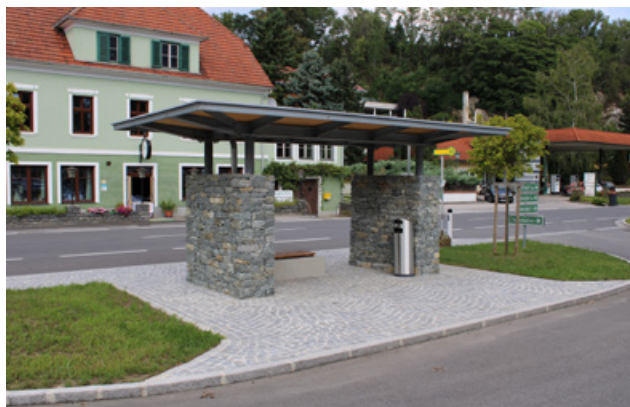
Fig. 42. M. Schimek, 2019, Location of the flood protection walls in Emmersdorf directly at the Danube

So far, the protection for the villages of Emmersdorf and the small settlement of Seegarten have been finished. In Emmersdorf, the scheme is 650 m long.⁵⁴ Except for a short part at the camping site, which is built as a tall wall, all other parts were constructed in the wall-aluminium style, with flood gates on both ends. The storage halls were built next to the camping site. A public toilet and an ATM desk were also integrated into the building. Since the walls in Emmersdorf were built on the outer side of the main road from the village, it was not possible to plant bushes, due to the steep gradient towards the Danube and the fact that the so-called Treppelweg, the maintenance road for the waterways authorities, is located between the Danube and the flood protection walls (fig. 42).

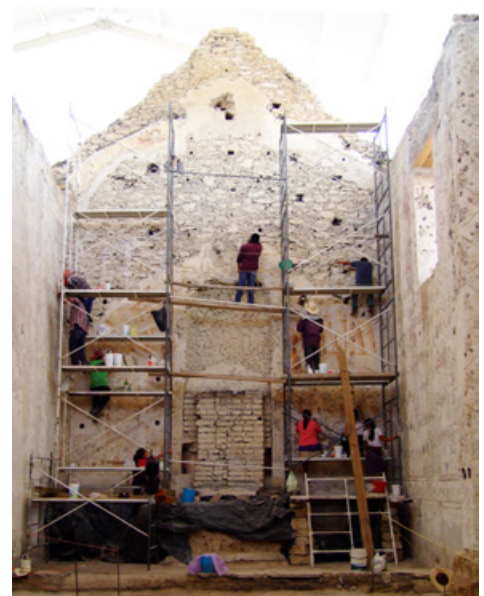
Fig. 11. Conservation treatments in mural paintings. (Image by Juan José Beltrán)

Parallel to the architectural rehabilitation work, mural paintings and severely altered bi-chromed plastered surfaces were restored over 18 months (fig. 11). During

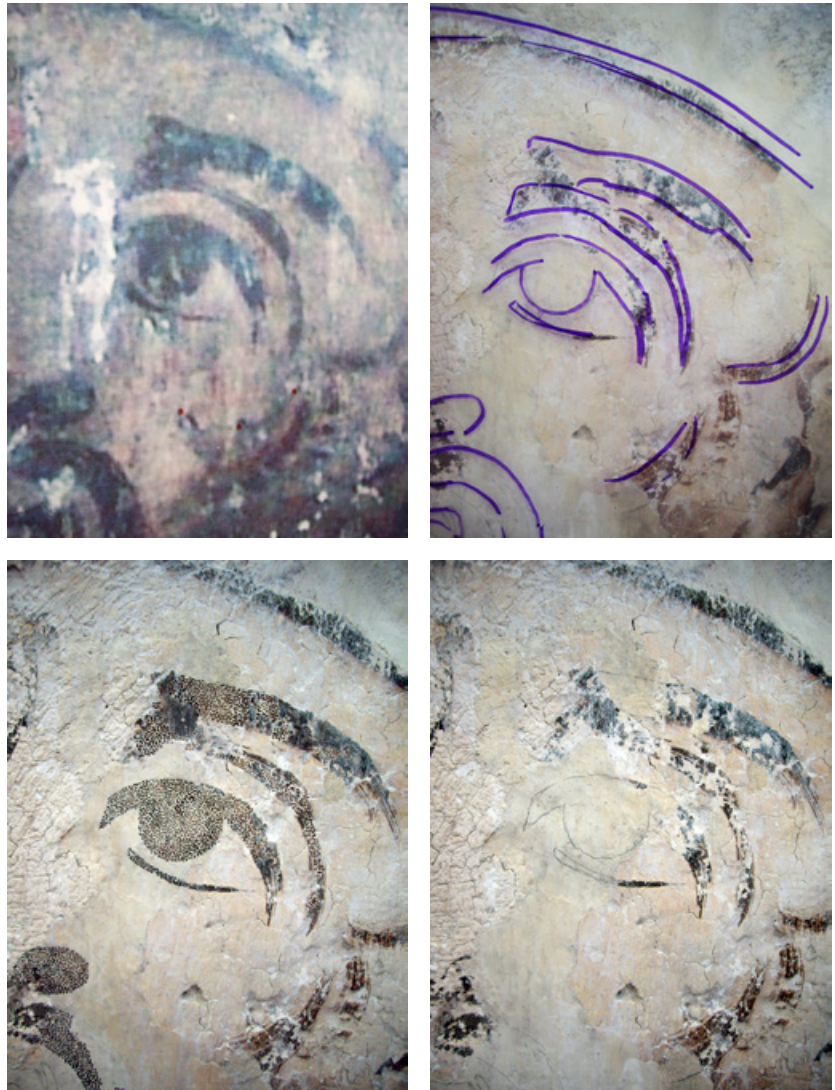
►
Images, Clockwise from top left:
Fig. 12. Mural Paintings: Chromatic Intervention Processes. (Images by Verónica Roque)
 A. Old Picture projection
 B. Decal
 C. Pencil drawing
 D. Final aspect

the last days of 2008 and throughout 2009, the scenes were chromatically restored based on acrylics and also with lime mixed with diluted sugars from cacti and mineral pigments applied using the pointillism technique on borders and repairs of lime, with sand and clay of the region. The reintegration was supported at all times using the photographic documentation carried out in 2006 (figg. 12A, 12B, 12C and 12D).

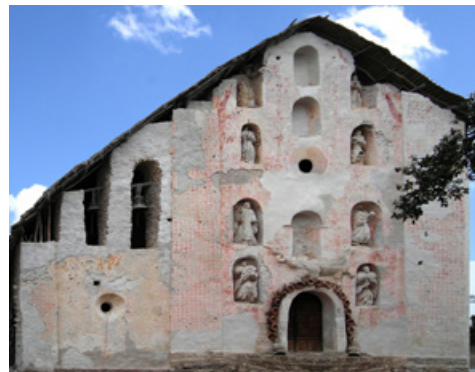
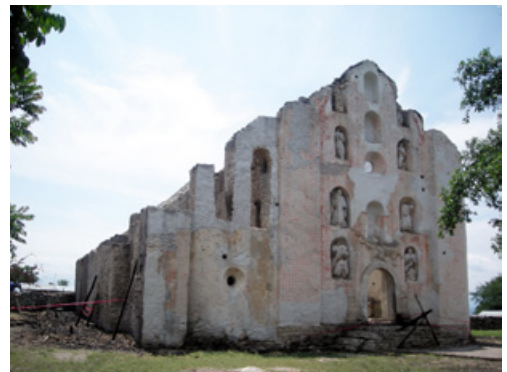
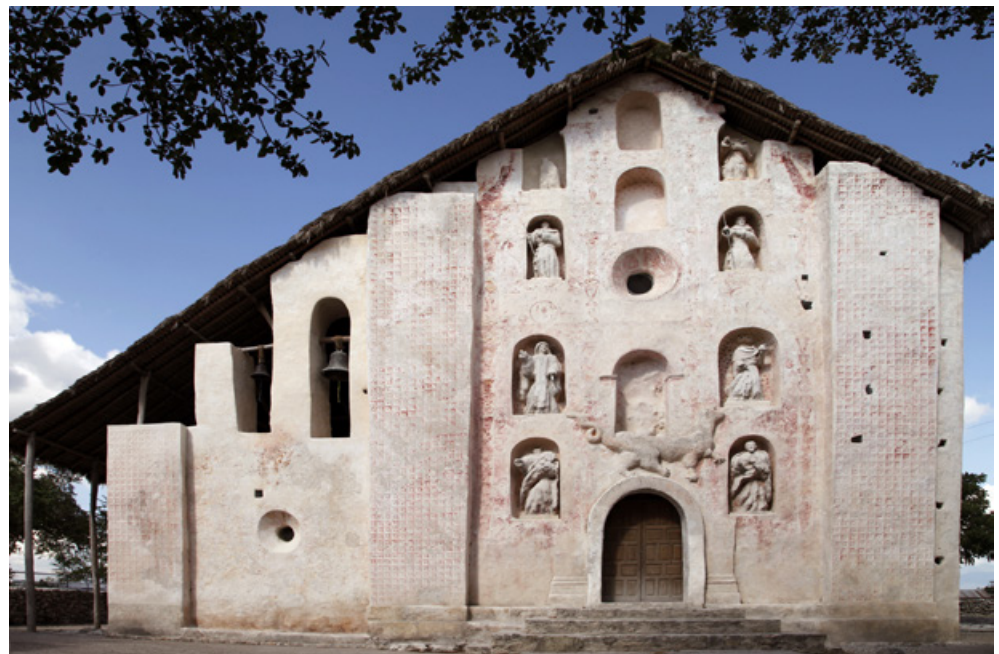
►
From top to bottom:
Fig. 16. Example of a register file
Fig. 17.
 (Left) A. The façade in 2006. (Image by Renata Schneider)
 (Right) B. The façade in July 2007. (Image by Renata Schneider)
 (Bottom) C. The façade in 2016. (Image by Julio Martínez)

A total of 759.54 m² of mural paintings were worked on (162.73 m² correspond to the façade and 596.81 m² to the inside), in addition to ten volumetric mortar elements (façade figures, inside pyxides, among other

elements), a baptismal font, a holy water font that includes a relief in mortar and four masonry altars that serve as altarpiece bases (figg. 17A, 17B and 17C).

The façade underwent an intervention of very poor quality and appearance, carried out with a poor mixture of lime-sand and a vinyl-based polymer: it urgently required work to eliminate the remains of previous interventions, consolidation, replacement of plastering and chromatic restitution. It is worth mentioning that we were never able to locate a single file that gave an account of the work done on the façade, not even the company's name or the contract conditions.

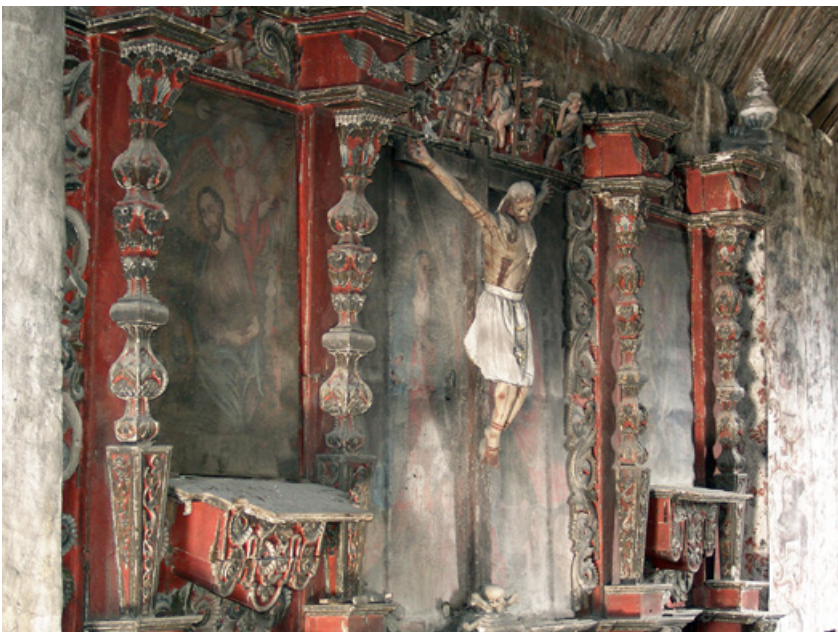
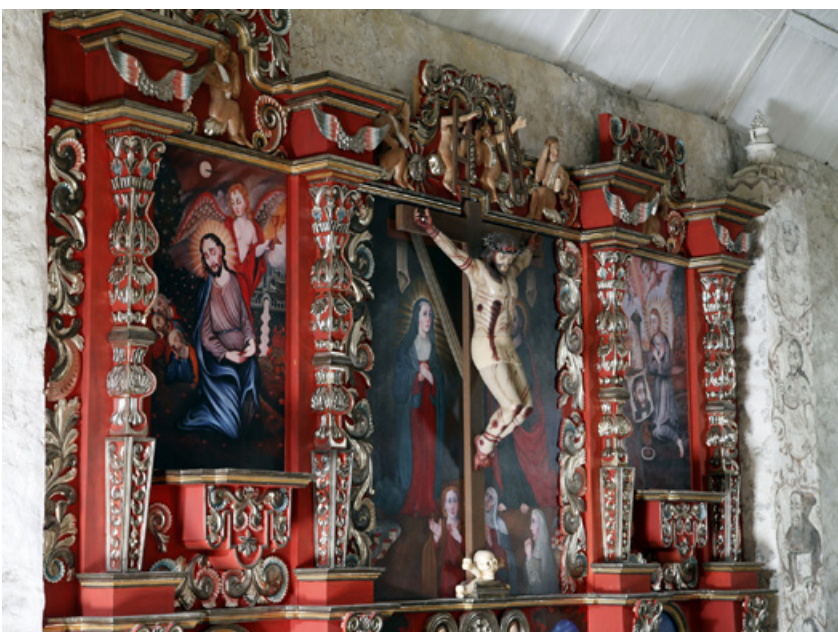
Fig. 18. Detail of the altarpiece of the *Seven Sorrows of the Virgin and the Passion of Christ*
 A. Original, December 2006. (Image by Gabriel Martínez)
 B. Reproduction, March 2013. (Image by Julio Martínez)

And finally, under the coordination of the movable property team, four altarpieces were reproduced, with their respective canvases or corresponding panel paintings. In the case of the altarpiece of the *Seven Sorrows of the Virgin and the Passion of Christ*, a copy of the sculpture of the large crucified Jesus, of the images of the Virgin of la Asunción and San Francisco in the

main altarpiece were also made, in addition to a pulpit (ambon and canopy), and a painting of the Virgin of Guadalupe. The main door, the access door to the chapel of rest (or pre-sacristy) and the window-lattice of the presbytery were also reproduced by local carpenters. The temple continues without electricity, as always (figg. 18A and 18B).

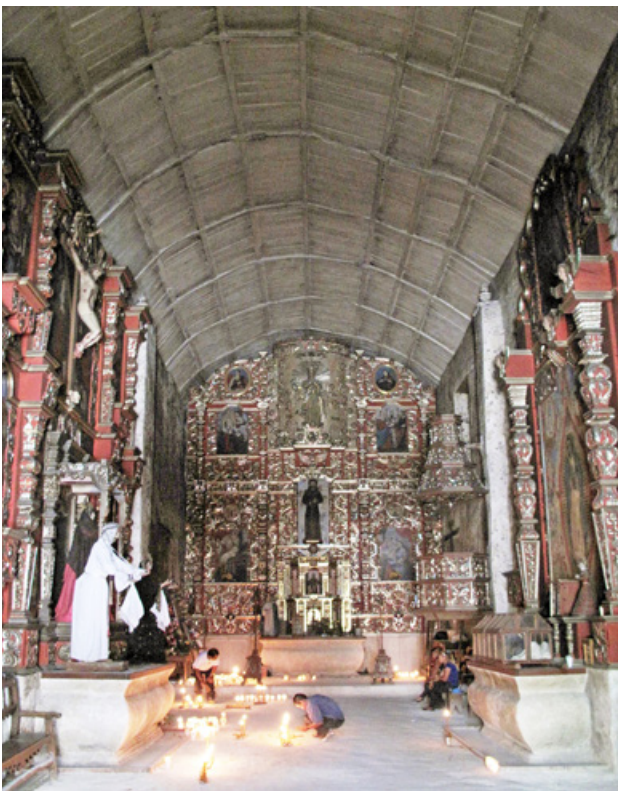
**From left to right:
Fig. 20.**

- A. The temple nave in 2006. (Image by Gabriel Martínez)
B. The temple nave in 2007, after being struck by lightning. (Image by Renata Schneider)
C. The temple nave in 2015. (Image by Renata Schneider)

From September 2007, the four altars damaged by the rain were stabilised and volumetrically restored using the same kind of material used to build them, that is, sun-dried brick and lime and sand plaster (enabling them to be ready to receive their corresponding altarpieces). Likewise, three mortar elements were worked on, and the presbytery bench and the general floor of the nave,

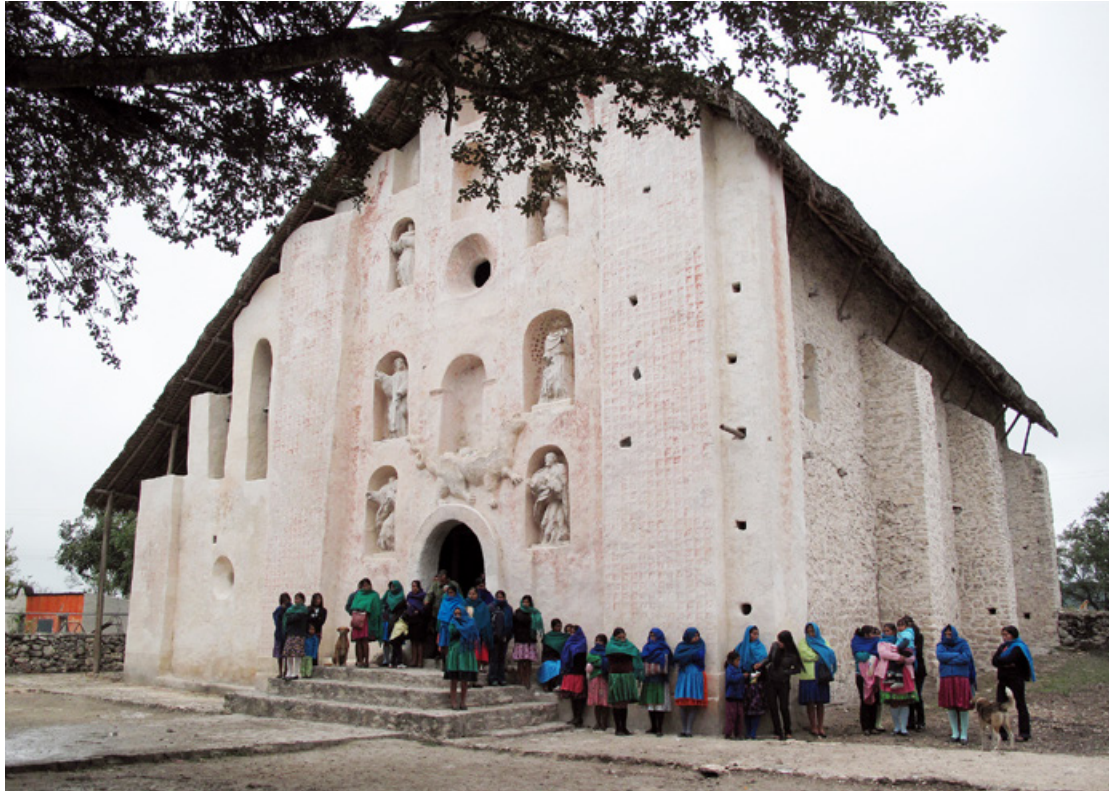
▲
Fig. 21. The Santa María Temple after the intervention. (Image by Renata Schneider)
